Excerpt from the 2015 Anoka Water Almanac

Chapter 3: Upper Rum River Watershed

Prepared by the Anoka Conservation District

UPPER RUM RIVER WATERSHED

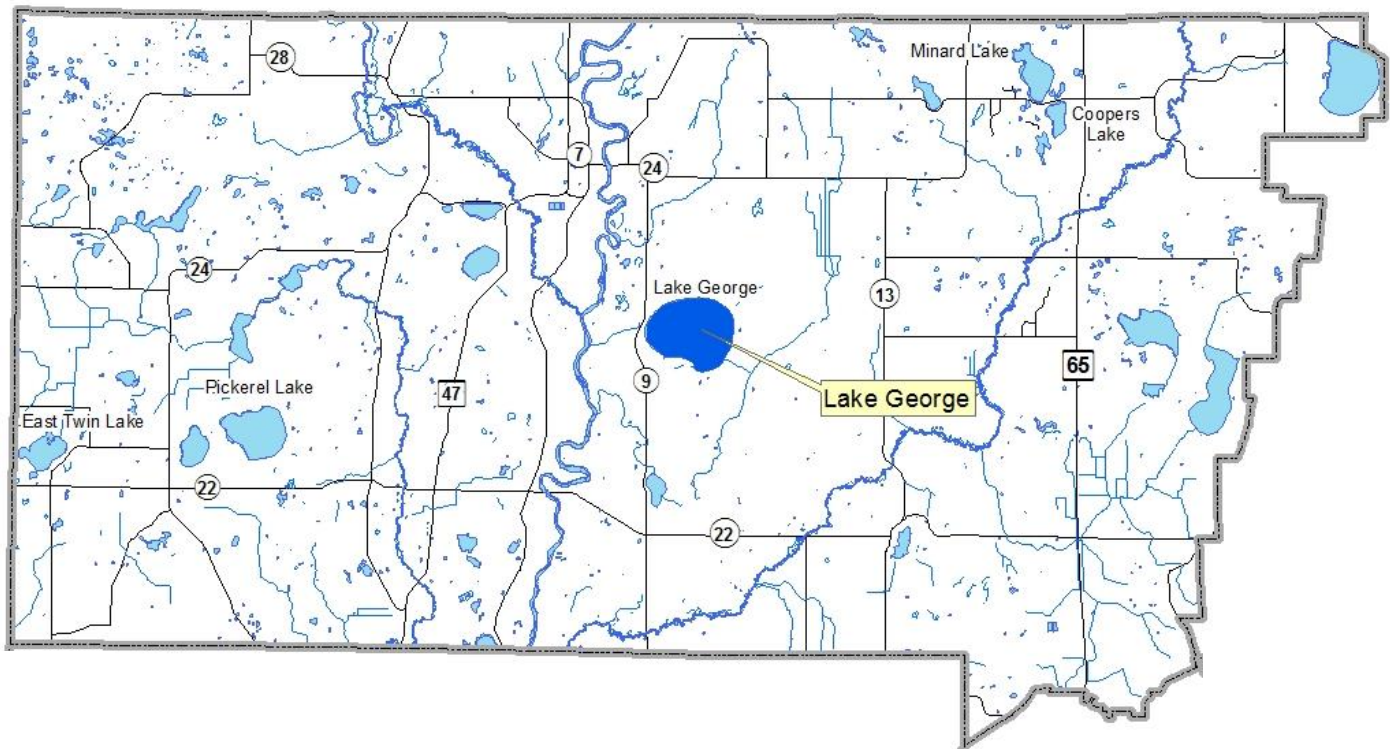
Upper Rum River Watershed Lake Water Quality Monitoring Sites

Results: Detailed data for each lake are provided on the following pages, including summaries of historical conditions and trend analysis. Previous years' data are available at the MPCA's electronic data access website. Refer to Chapter 1 for additional information on interpreting the data and on lake dynamics.

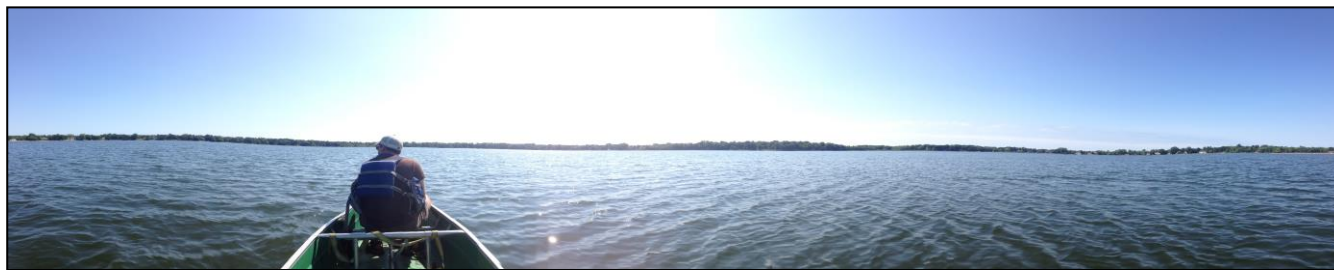
CITY OF OAK GROVE, LAKE ID # 02-0091

Lake George is located in north-central Anoka County. The lake has a surface area of 535 acres with a maximum depth of 32 feet (9.75 m). Public access is from Lake George County Park on the lake's north side, where there is both a swimming beach and boat launch. About 70% of the lake is circumscribed by homes; the remainder is county parkland. The watershed is mostly undeveloped or vacant, with some residential areas, particularly on the lakeshore and in the southern half of the watershed. Two invasive exotic aquatic plants are established in this lake, Curly-leaf pondweed and Eurasian Water Milfoil. The lake improvement district treats both with herbicide.

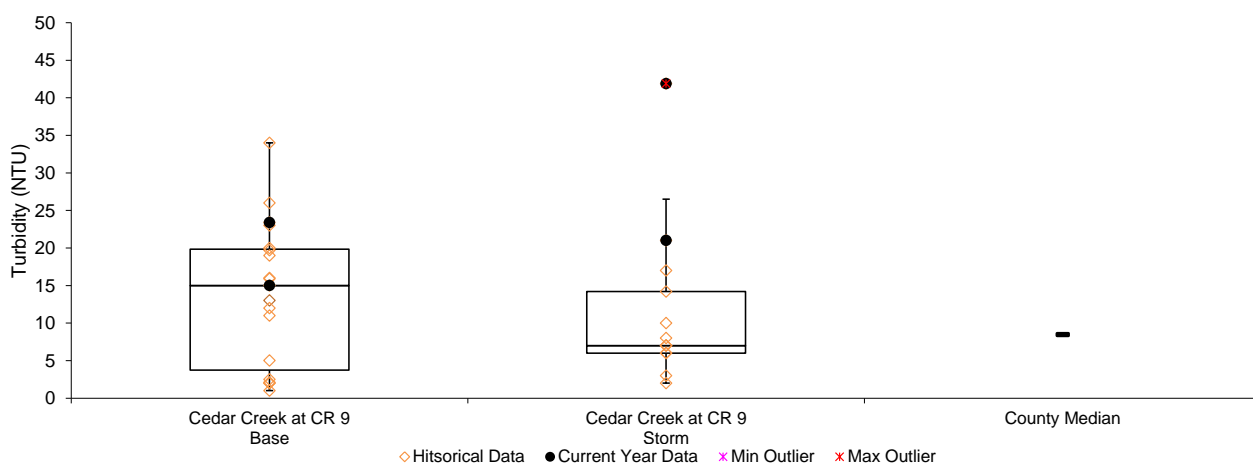
In Cedar Creek, turbidity was low overall with slight increases during storms events. The median turbidity (all years) is 15 NTU during baseflow and only 7 NTU during storm events, which is similar to the median for Anoka County streams of 8.5 FNRU. Turbidity was elevated on a few occasions, especially during storms. In 2015 the maximum observed was 41.5 NTU during a mid-season monitoring event. This is the highest reading on record. TSS was high throughout 2015 with all readings being above the median for Anoka County streams which is 12 mg/L. In some cases TSS was over 10 times higher in 2015 than 2014. During one storm event an all-time high of 64 mg/L was recorded. Even with high 2015 results median TSS (all years) is 13.5 mg/L during baseflow and 11.5 mg/L during storm events.

Turbidity during baseflow and storm conditions Orange diamonds are historical data from previous years and black circles are 2015 readings. Box plots show the median (middle line), 25th and 75th percentile (ends of box), and 10th and 90th percentiles (floating outer lines).

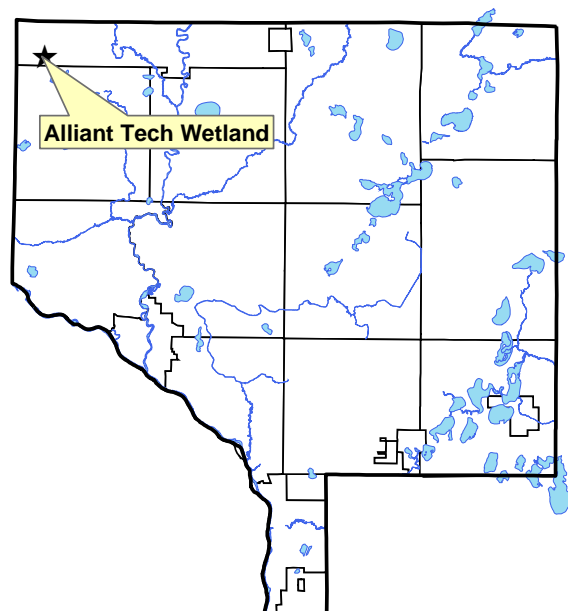
Scientific	Common	% Coverage
Carex Spp	Sedge undiff.	90
Lycopus americanus	American Bungleweed	20
Phalaris arundinacea	Reed Canary Grass	5

Other Notes: This wetland lies next to the highway, in a low area surrounded by hilly terrain. It holds water throughout the year, and has a beaver den.
