# 2023 Annual Report

## Upper Rum River

### Watershed Management Organization

Prepared by the Anoka Conservation District

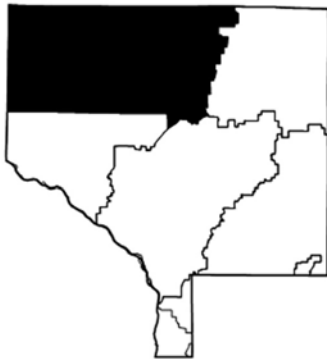
# Monitoring Sites: Upper Rum River Watershed

2023 Monitoring Sites	
	Groundwater Hydrology
	Volunteer Precipitation
	Anoka County Weather
	Lake Levels
	Wetland Hydrology
	Stream WQ
	Lakes WQ

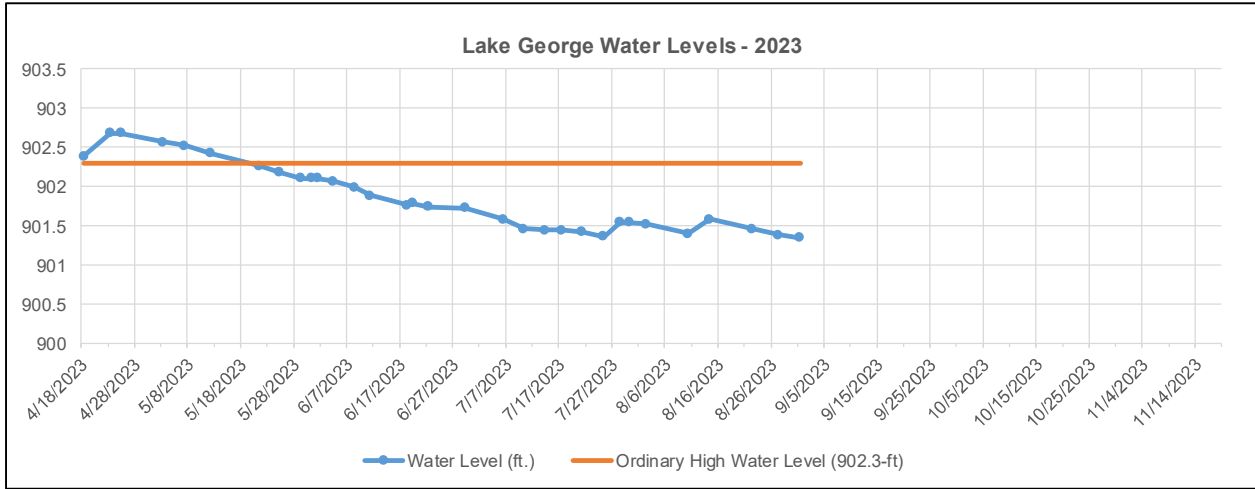
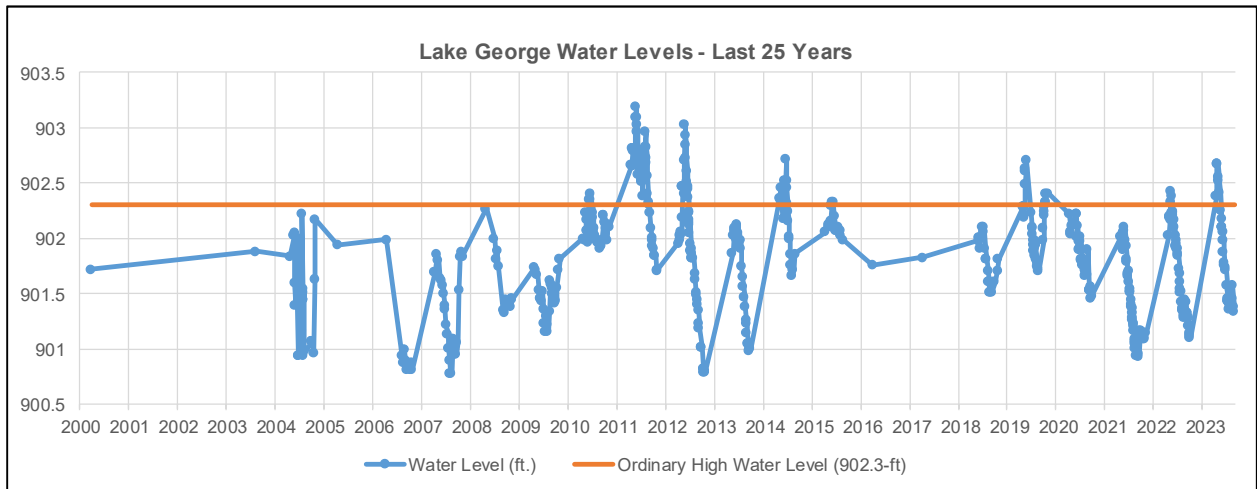
# Lake George

**Results:** **Lake George.** In spring 2023, Lake George had the fifth highest water levels in the last 23 years. Drought conditions developed the remainder of the growing levels, and water levels dropped 1.34 feet. Overall, water levels were within the range observed in the past, but water levels this high and low are observed every five years, on average.

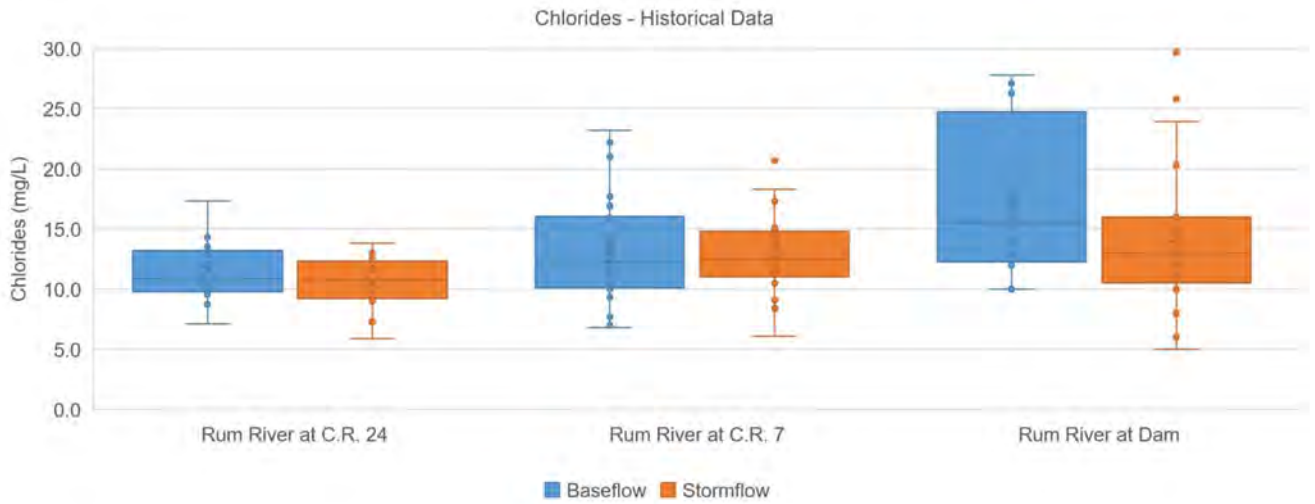
**Chlorides during Baseflow and Storm Conditions.** Box plots show the median (middle line), 25<sup>th</sup> and 75<sup>th</sup> percentile (ends of box), and 10<sup>th</sup> and 90<sup>th</sup> percentiles (floating outer lines). Historical boxplot data also includes this year's data.

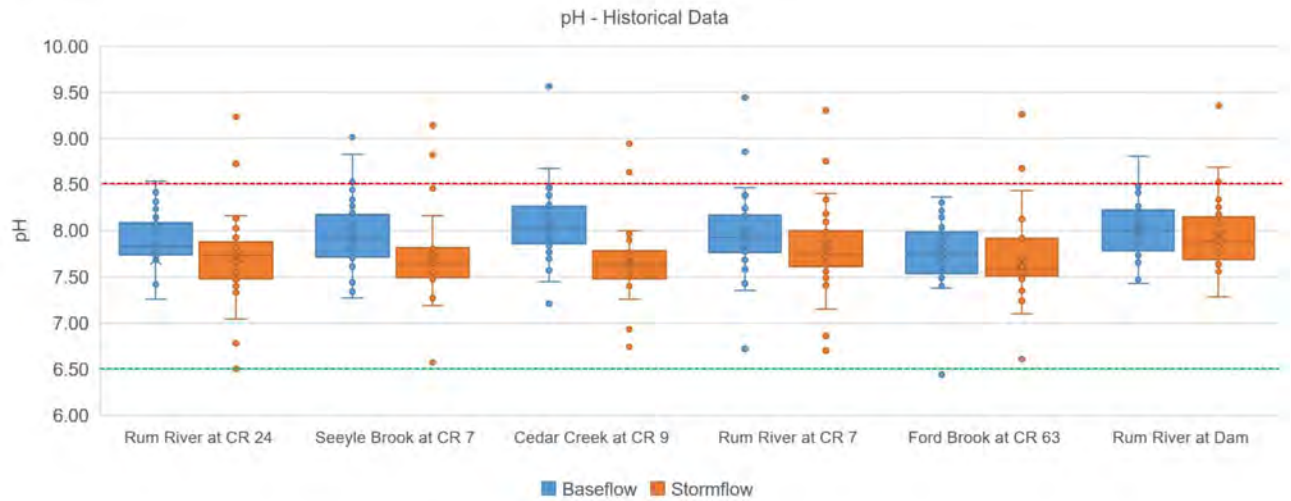
**pH during Baseflow and Storm Conditions.** Box plots show the median (middle line), 25<sup>th</sup> and 75<sup>th</sup> percentile (ends of box), and 10<sup>th</sup> and 90<sup>th</sup> percentiles (floating outer lines). Historical boxplot data also includes this year's data.

pH refers to the acidity of the water. The state standard range for pH is between 6.5 - 8.5, and pH is generally lower during storm events than during baseflow conditions because the pH of rain is typically lower (more acidic). While acid rain is a longstanding problem, its effect on this aquatic system is minimal. The rare occasions when pH is below or exceeds the state standard should not be concerning. No sampling occasions were below or exceeded the state standard range during 2023 at any of the monitoring sites.

**Rum River.** In 2023, the average pH in the Rum River was 7.93 during baseflow conditions and 7.78 post-storm. Historically, the Rum River exceeded the state standard on eleven occasions, and has been below the state standard on only two occasions.

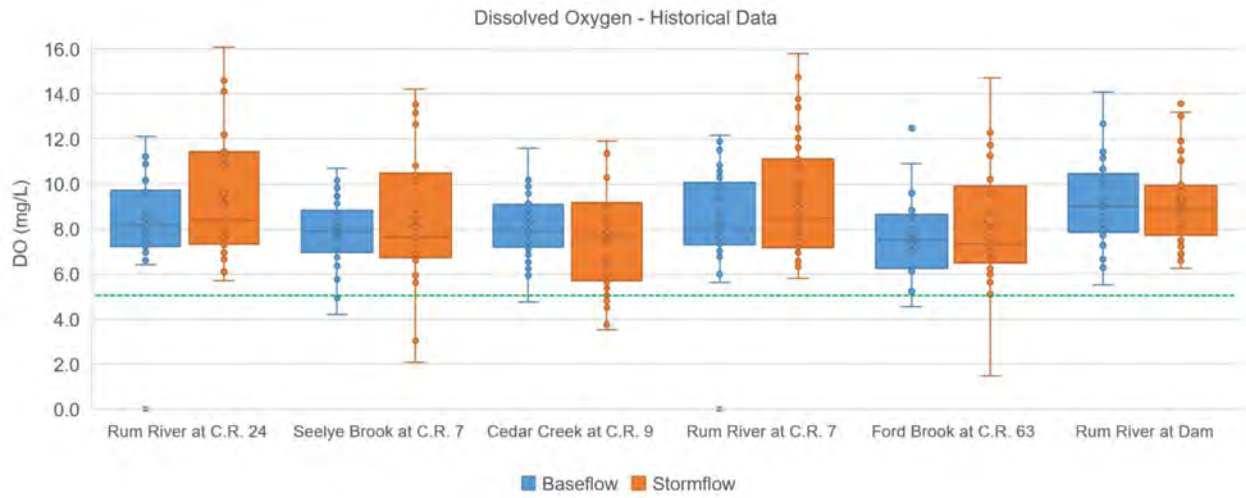
**Dissolved Oxygen during Baseflow and Storm Conditions.** Box plots show the median (middle line), 25<sup>th</sup> and 75<sup>th</sup> percentile (ends of box), and 10<sup>th</sup> and 90<sup>th</sup> percentiles (floating outer lines). Historical boxplot data also includes this year's data.

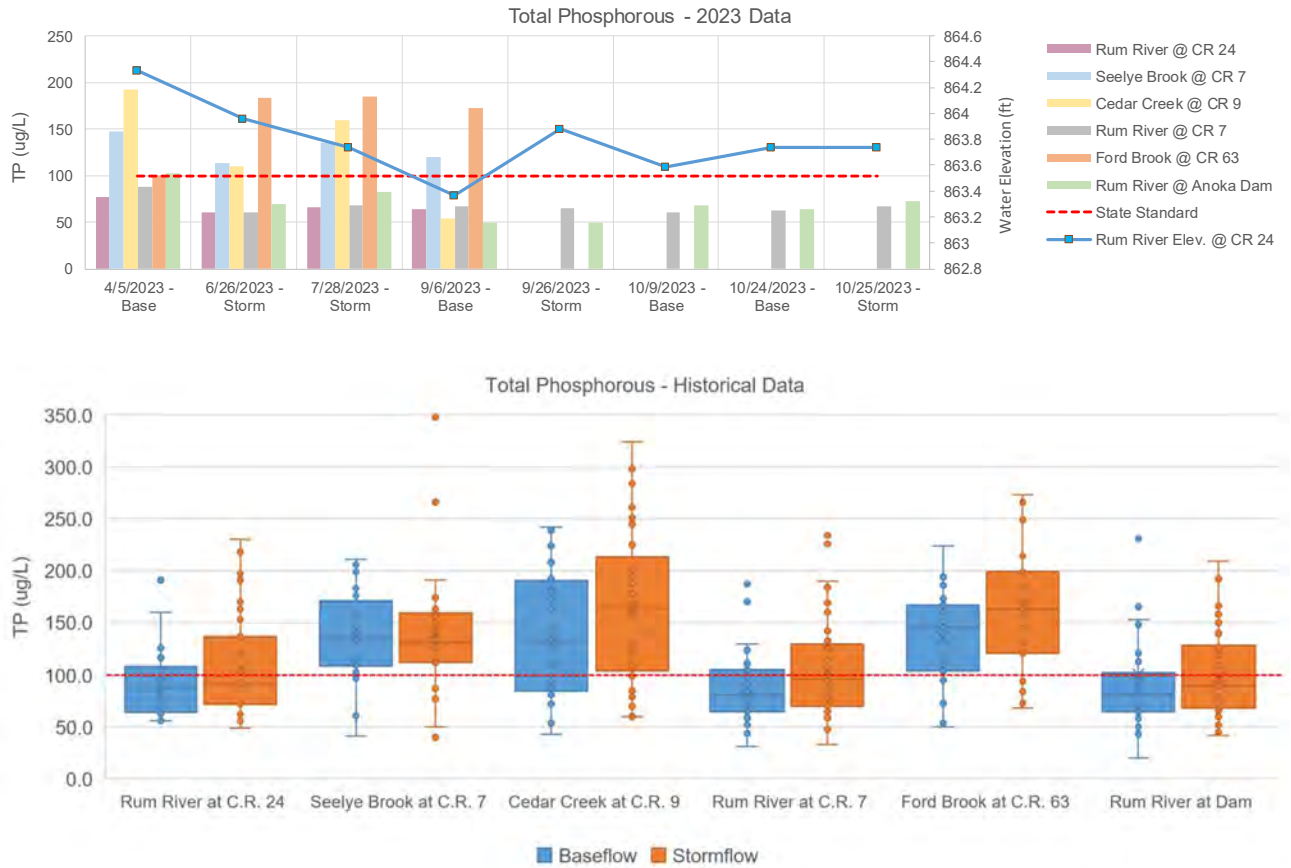
**Total Phosphorus during Baseflow and Storm Conditions.** Box plots show the median (middle line), 25<sup>th</sup> and 75<sup>th</sup> percentile (ends of box), and 10<sup>th</sup> and 90<sup>th</sup> percentiles (floating outer lines). Historical boxplot data also includes this year's data.

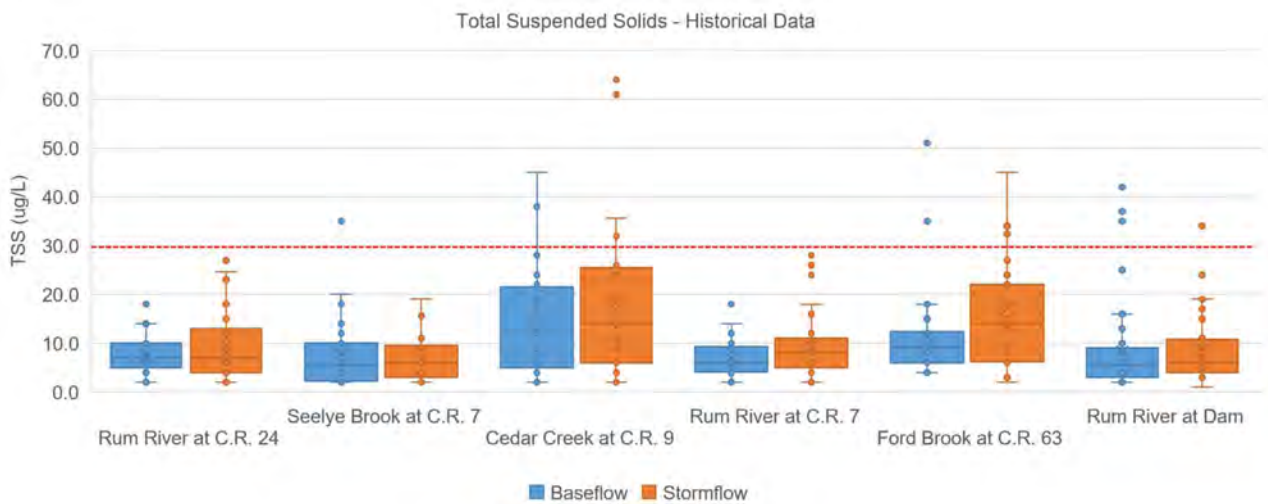
**Total Suspended Solids during Baseflow and Storm Conditions.** Box plots show the median (middle line), 25<sup>th</sup> and 75<sup>th</sup> percentile (ends of box), and 10<sup>th</sup> and 90<sup>th</sup> percentiles (floating outer lines). Historical boxplot data also includes this year's data.

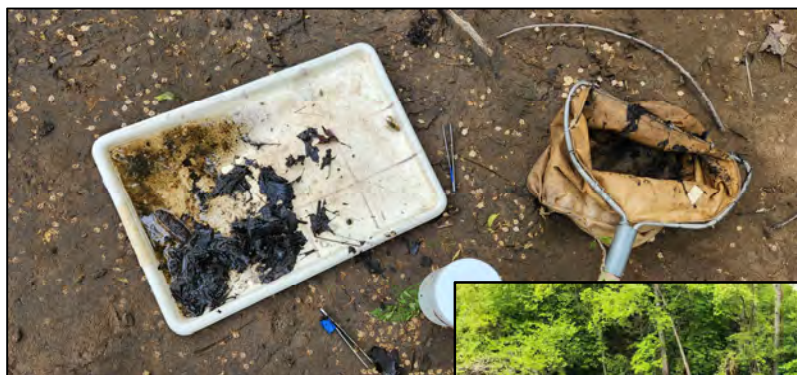
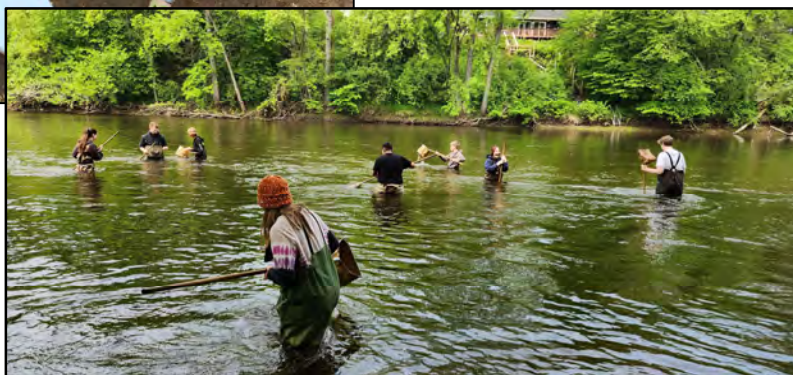
**Summarized Biomonitoring Results for Rum River North County Park, St. Francis**  
(samplings by St. Francis High School and Crossroads Schools in 2002-2003 are averaged)

All students who participated in 2023 sampling were part of sophomore biology courses. All specimens were identified to the best of the students' abilities for a rapid assessment in the field and then returned to the river. As a result, no preserved samples are available for ACD identification and inclusion in the Water Almanac.

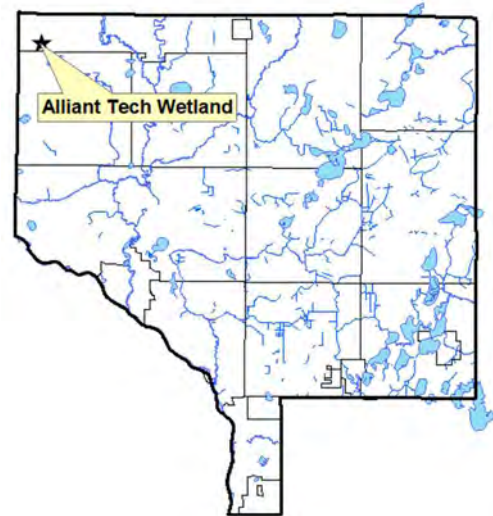
**Monitored Since:** 2001  
**Wetland Type:** 5  
**Wetland Size:** ~12 acres  
**Isolated Basin:** Yes  
**Connected to a Ditch:** No  
**Surrounding Soils:** Emmert

Horizon	Depth	Color	Texture	Redox
A	0-8	N2/0	Murky loam	-
Bg	8-35	5y5/1	Sandy Loam	-

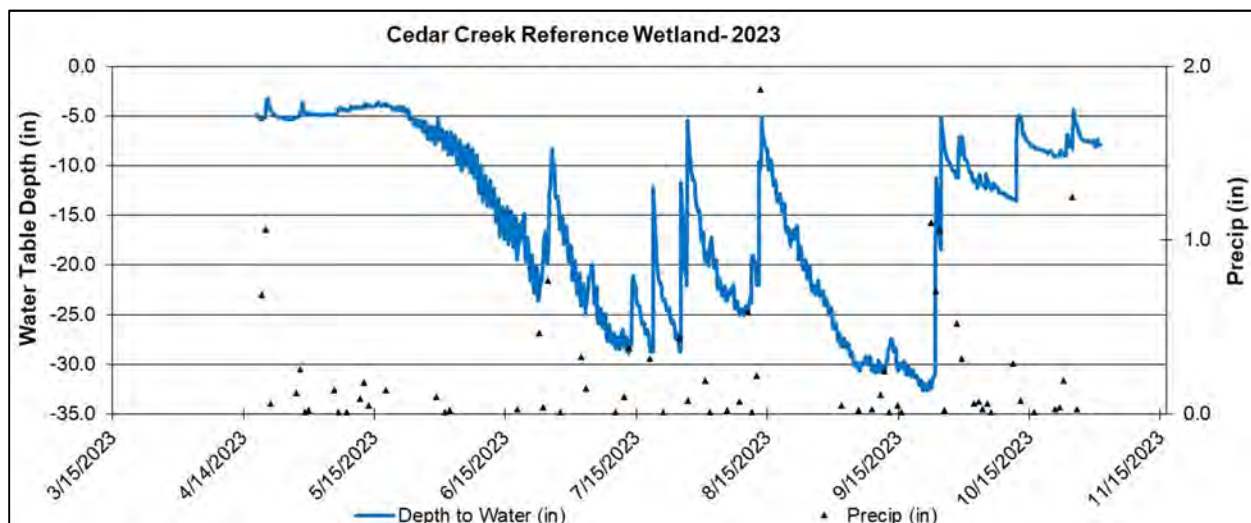
### 2023 Hydrograph (Well Depth 40 inches)

<b>Monitored Since:</b>	1996
<b>Wetland Type:</b>	6
<b>Wetland Size:</b>	>150 acres
<b>Isolated Basin:</b>	No
<b>Connected to a ditch:</b>	No
<b>Surrounding Soils:</b>	Zimmerman
<b>Soils at Well Location:</b>	Not yet available
<b>Vegetation at Well Location:</b>	Not yet available

**Other Notes:** This wetland is located within a science research reserve, operated by the University of Minnesota. Much of this area, including the area surrounding the monitoring site, is in a natural state. This wetland probably has some hydrologic connection to the floodplain of Cedar Creek.

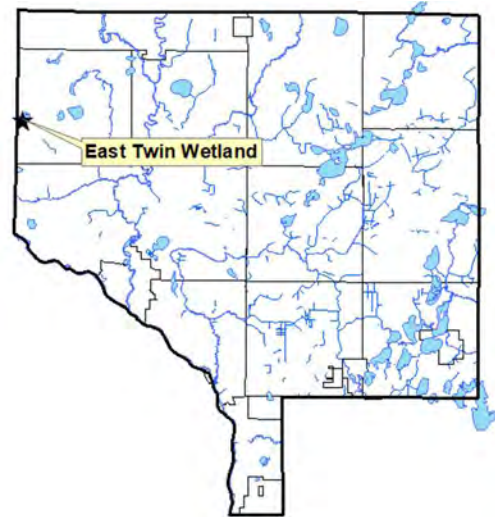
**Monitored Since:** 2001  
**Wetland Type:** 5  
**Wetland Size:** ~5.9 acres  
**Isolated Basin:** Yes  
**Connected to a Ditch:** No  
**Surrounding Soils:** Lake Beach, Growton and Heyder fine sandy loam

Horizon	Depth	Color	Texture	Redox
A	0-8	10yr 2/1	Mucky Loam	-
Oa	Aug-40	N2/0	Organic	-

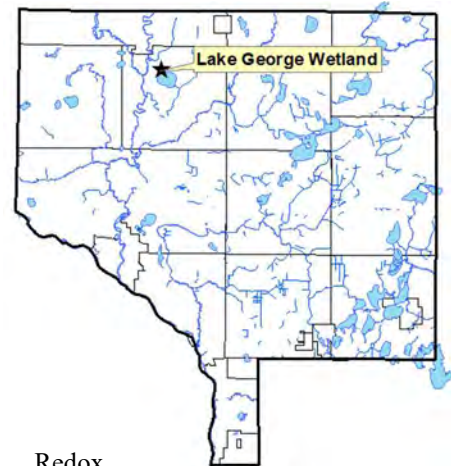
**Monitored Since:** 1997  
**Wetland Type:** 3/4  
**Wetland Size:** ~9 acres  
**Isolated Basin:** Yes  
**Connected to a Ditch:** No  
**Surrounding Soils:** Lino loamy fine sand and Zimmerman fine sand

Horizon	Depth	Color	Texture	Redox
A	0-8	10yr2/1	Sandy Loam	-
Bg	8-24	2.5y5/2	Sandy Loam	20% 10yr5/6
2Bg	24-35	10gy 6/1	Silty Clay Loam	10% 10yr 5/6

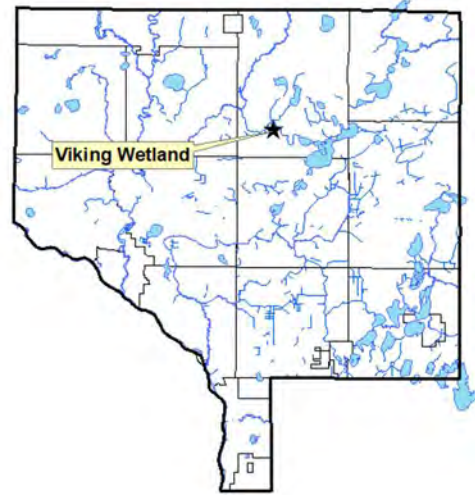
**Monitored Since:** 1999  
**Wetland Type:** 2  
**Wetland Size:** ~0.7 acres  
**Isolated Basin:** No  
**Connected to a Ditch:** Yes  
**Surrounding Soils:** Zimmerman fine sand

Horizon	Depth	Color	Texture	Redox
A	0-12	10yr2/1	Sandy Loam	-
Ab	12-16	N2/0	Sandy Loam	-
Bg1	16-25	10yr4/1	Sandy Loam	-
Bg2	25-40	10yr4/2	Sandy Loam	5% 10yr5/6

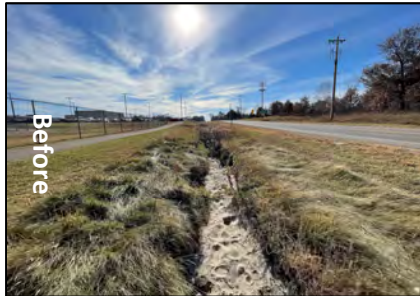
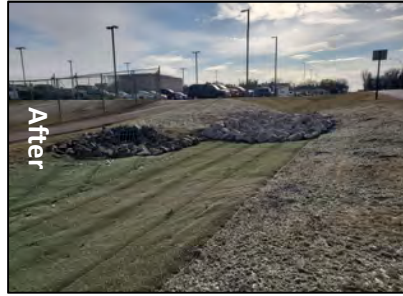
A roadside swale stabilization was completed on the west side of the St. Francis High School campus. The project stabilized a 460 ft eroding swale. The project was a priority because the swale terminates in a stream that drains to the Rum River less than 500 ft downstream. The swale receives a large amount of runoff from the high school and adjacent lands. The 9.97 ac drainage is more than half impervious surface. Funding was from a Watershed Based Implementation Funding (WBIF) grant and the Upper Rum River Watershed Management Organization. Partners included the City of St. Francis, St. Francis High School, and Anoka Co Highway Department.

**Photos: Site conditions before (left) and after (right).**

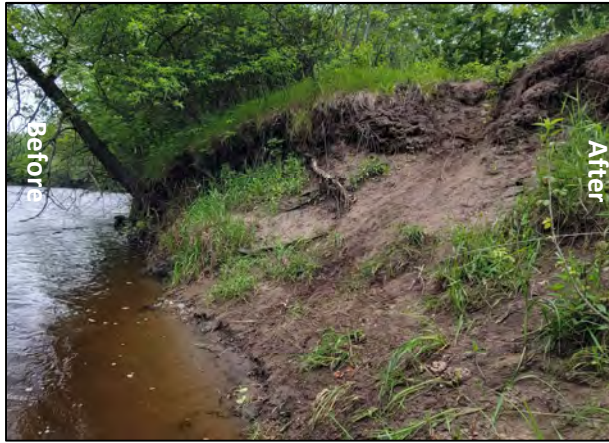
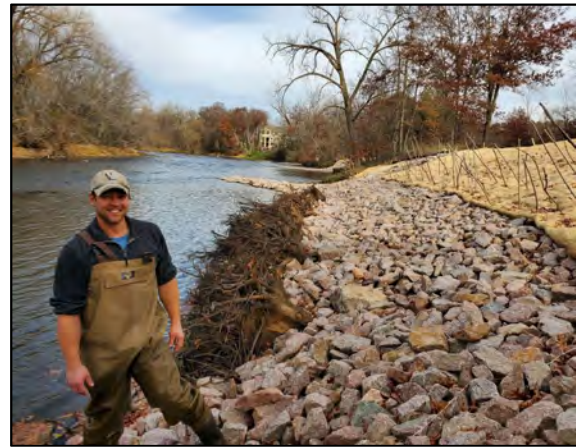
Moderate to severe bank erosion along 630 feet of Rum Riverbank in Dellwood River Park (St. Francis) was causing significant tree and soil loss and was threatening a public walking trail. Several practices were used to stabilize the riverbank including three rock bendway weirs that deflect flow away from the bank, rock rip rap, root wads, and cedar tree revetments. Funding was from the Lessard-Sams Outdoor Heritage Fund City of St. Francis, and Anoka County.

**Photos: Site conditions before (left) and after (right).**

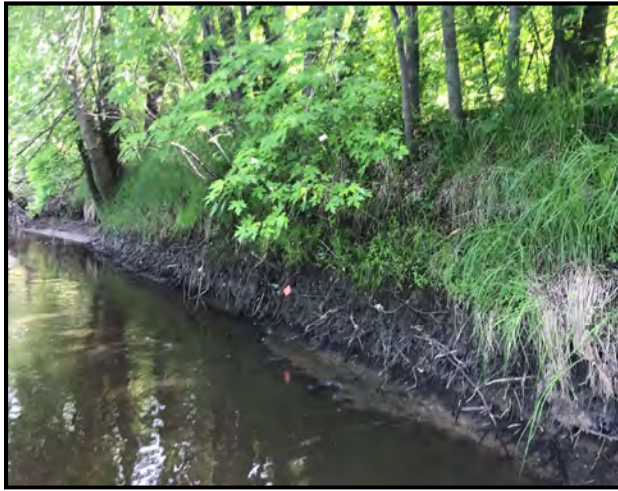
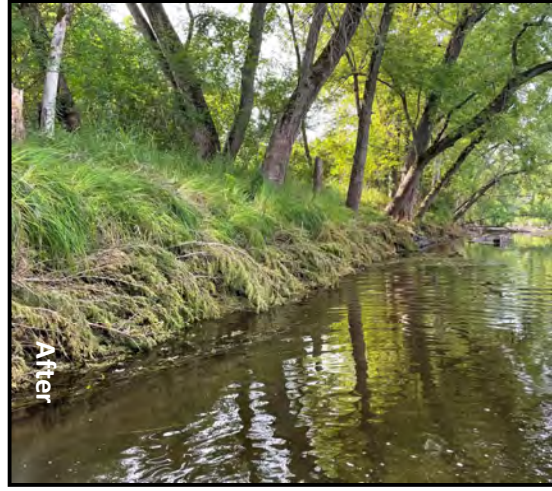
Anoka Conservation District (ACD) in partnership with the Conservation Corps of Minnesota & Iowa (CCMI) and Anoka County Parks installed a cedar tree revetment within the Cedar Creek Conservation Area in Oak Grove. Installation of this revetment has been ongoing from 2021-2023 and totals 2,305 linear feet. The cut cedar trees, anchored to the bank, provide soft armor to prevent erosion. Shrubs are planted by live staking for long term stabilization. Funding was from a MN DNR Conservation Partners Legacy grant, grant of crew time from the Conservation Corps of MN and IA, and donated materials

**Photos: Site conditions before (left) and after (right).**
