# ERICKSON LAKESHORE RESTORATION OAK GROVE, MN

## Project Summary

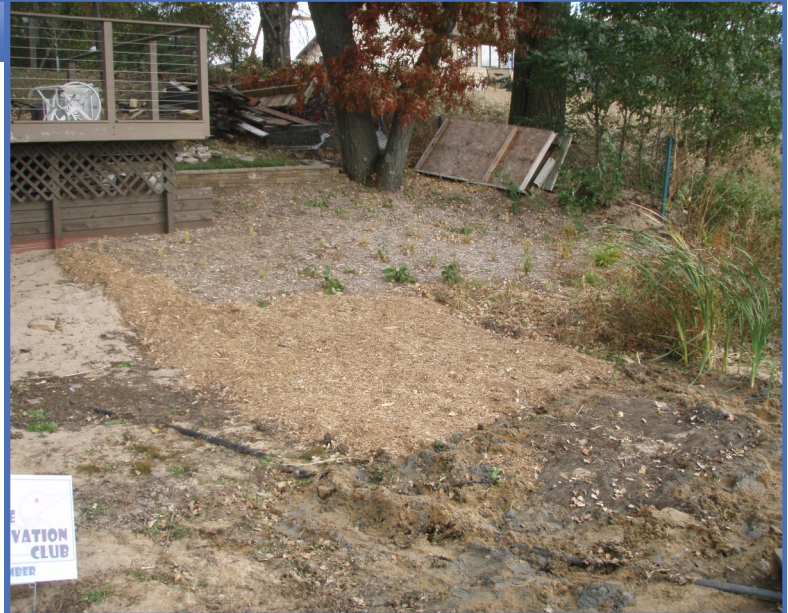
Completed project in the fall of 2012.

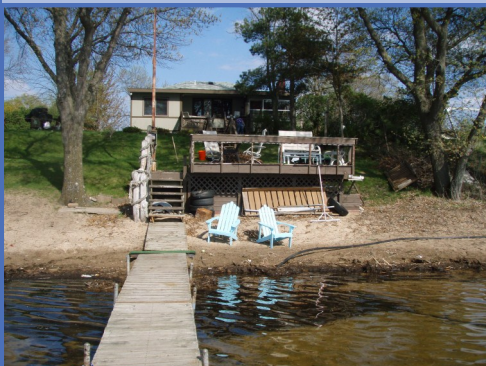
Pre-restoration conditions consisted of little vegetation, which provided no benefits to water quality, wildlife habitat, or shoreline stability.

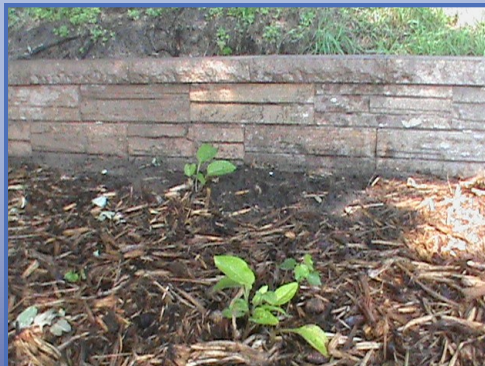
Sod was removed prior to the installation of a small retaining wall, erosion control blanket, shredded hardwood mulch, and native plant plugs.

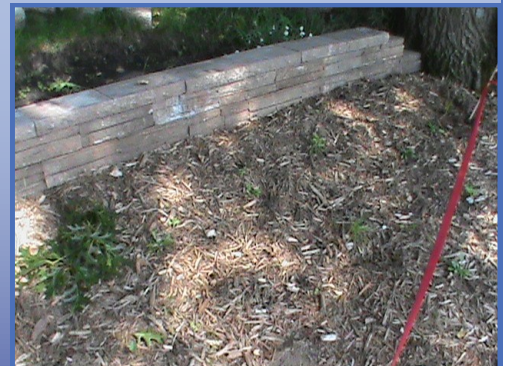
These practices will benefit habitat and water quality. In addition, the elaborate root system of the established native plant community will increase shoreline stability.
