# 2022 Annual Report

# Upper Rum River

Watershed Management Organization

# Draft excerpt from the 2022 Water Almanac

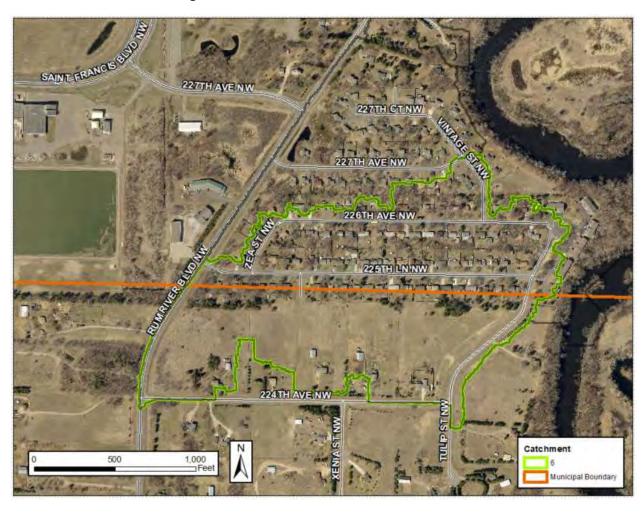
225<sup>th</sup> Lane and 226<sup>th</sup> Ave rain gardens area

225<sup>th</sup> Lane and 226<sup>th</sup> Ave rain gardens – landowner outreach

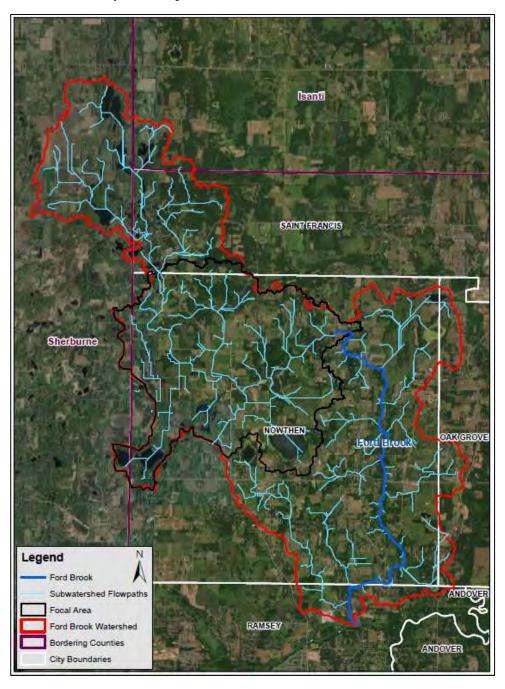
#### Ford Brook study area map

ACD has completed a study to identify and rank water quality improvement projects to benefit Ford Brook and the Rum River downstream. Study components include water monitoring to identify priority areas, modeling, project identification, cost benefit analysis for each project, and project ranking. The study is paid for by a State Watershed Based Implementation Fund grant and URRWMO matching funds. Completion is expected in early 2023.
