# Upper Rum River Watershed

Upper Rum River Watershed Management Organization  
[www.urrwmo.org](http://www.urrwmo.org)  
763-753-1920

## CHAPTER 3: UPPER RUM RIVER WATERSHED

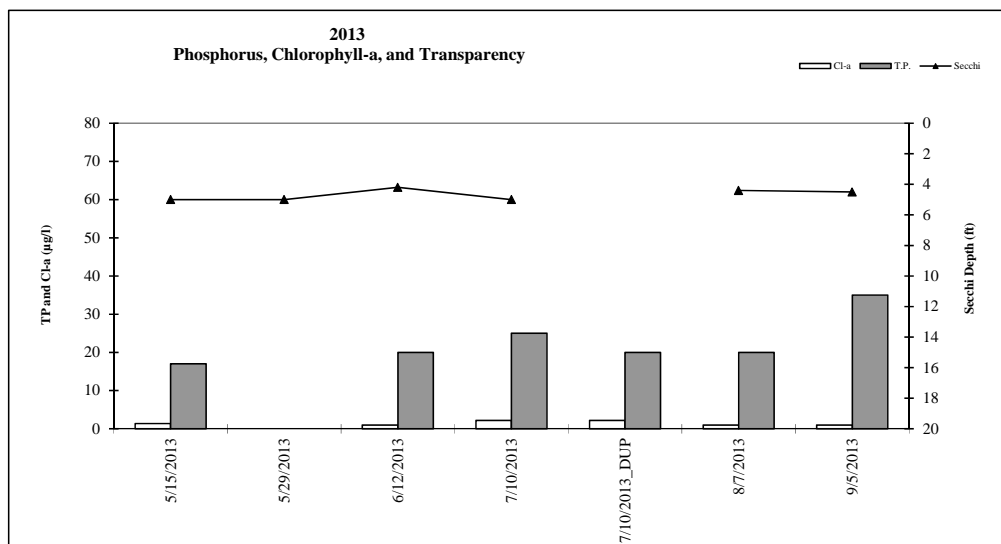
In 2013, the overall water quality grade for Minard Lake was an A grade. The limited data available indicates that the lake is mesotrophic. In 2013 the average surface total phosphorus (TP) concentration was 23 µg/l (maximum of 35 µg/l and a minimum of 10 µg/l) receiving an A grade. The average Chlorophyll-a (Cl-a) concentration was 1.5 µg/l (maximum of 2.2 µg/l and a minimum of 1.0 µg/l) receiving an A grade. The average Secchi disk measurement was 4.7 feet (maximum of 5 ft. and a minimum of 4.2 ft.) receiving a D grade, though this is not an accurate measure of transparency because readings often could not be taken because transparency was greater than the depth at which plants obscured measurements. Therefore, Secchi transparency is not included in the overall grade for the lake.

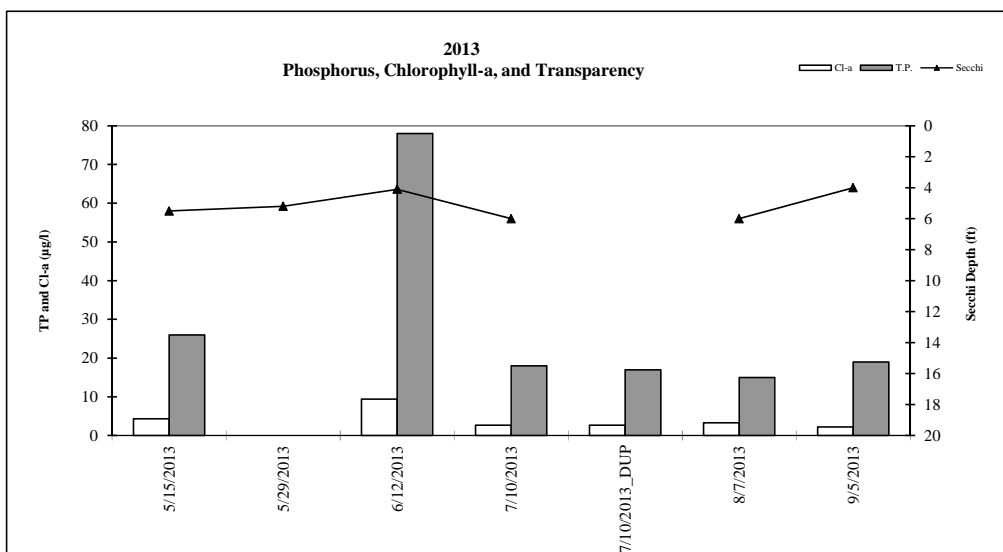
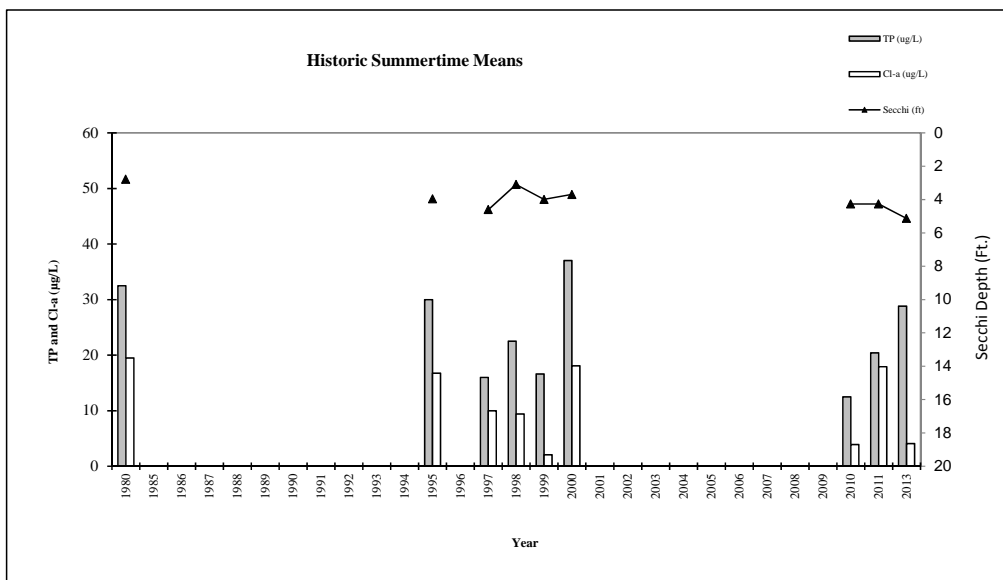
In 2013, Pickerel Lake had above average water quality, receiving a B+ grade. The average surface total phosphorus (TP) concentration was 29 µg/l (maximum of 78 µg/l and a minimum of 15 µg/l) receiving a B grade. TP was slightly above the historical average and the highest monitored since 2000. The average Chlorophyll-a (Cl-a) concentration was 4.1 µg/l (maximum of 9.4 µg/l and a minimum of 2.2 µg/l) falling well below the historical average and receiving an A grade. The average Secchi transparency measurement was 5.1 feet (maximum of 6 ft. and a minimum of 4.0 ft.) receiving a C grade. The shallow depth of the lake and aquatic vegetation prohibited representative Secchi disk measurements so this parameter was not included in the overall grade for the lake.

Nine years of water quality data have been collected by the Metropolitan Council (1980, 1995, 2010 and 2011) and the Anoka Conservation District (1997, 1998, 1999, 2000, and 2013). Water quality has not significantly changed from 1980 to 2013 (repeated measures MANOVA with response variables TP, Cl-a, and Secchi depth,  $F_{2,6}=1.02$ ,  $p>0.05$ ).
