# Excerpt from the 2014 Anoka Water Almanac

## *Chapter 3: Upper Rum River Watershed*

Prepared by the Anoka Conservation District

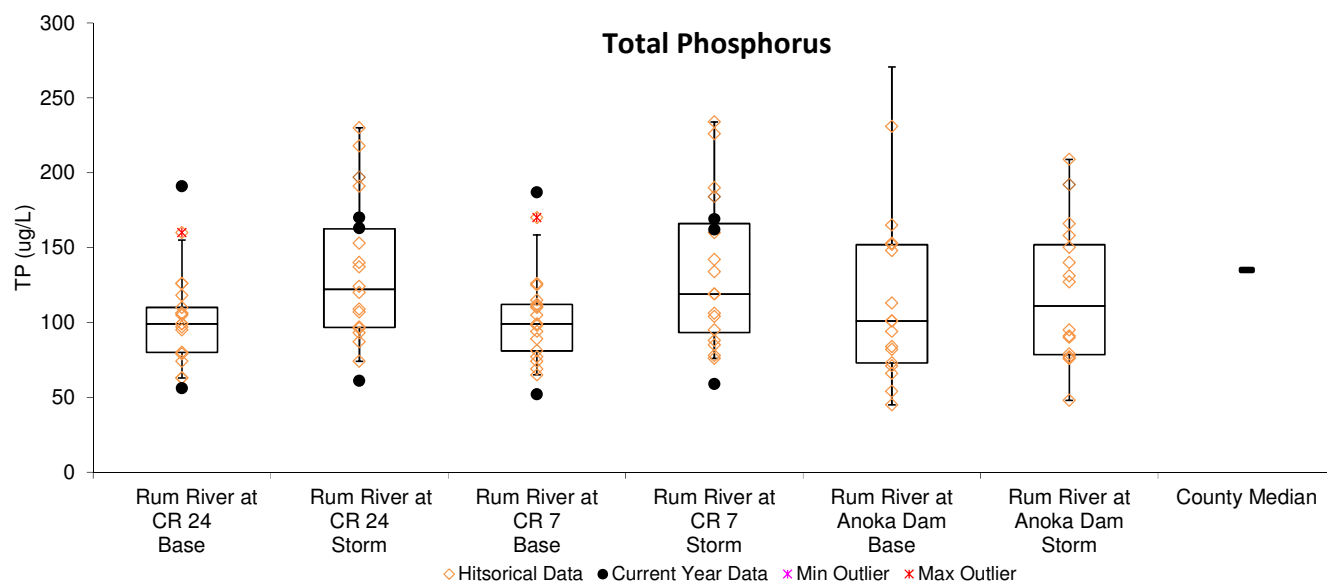
Total phosphorus in the Rum River is acceptably low and is similar to the median for all other monitored 34 Anoka County streams (see figure below). Though 2014 did find some of the highest and lowest readings ever observed. This nutrient is one of the most common pollutants in our region, and can be associated with urban runoff, agricultural runoff, wastewater, and many other sources. The median phosphorus concentration at the two monitored sites was 163 and 162 ug/L. These upstream-to-downstream differences are negligible and there is no trend of increasing phosphorus downstream. All sites occasionally experience phosphorus concentrations higher than the median for Anoka County streams of 135 ug/L. In 2014 the highest observed total phosphorus readings were during one particular baseflow event, including the maximums at each site of 191 and 187 ug/L (upstream to downstream). In all, phosphorus in the Rum River is at acceptable levels but should continue to be an area of pollution control effort as the area urbanizes.

**Total phosphorus during baseflow and storm conditions** Box plots show the median (middle line), 25<sup>th</sup> and 75<sup>th</sup> percentile (ends of box), and 10<sup>th</sup> and 90<sup>th</sup> percentiles (floating outer lines).
