# Excerpt from the 2018 Anoka Water Almanac

## *Chapter 3: Upper Rum River Watershed*

Prepared by the Anoka Conservation District

# Upper Rum River Watershed

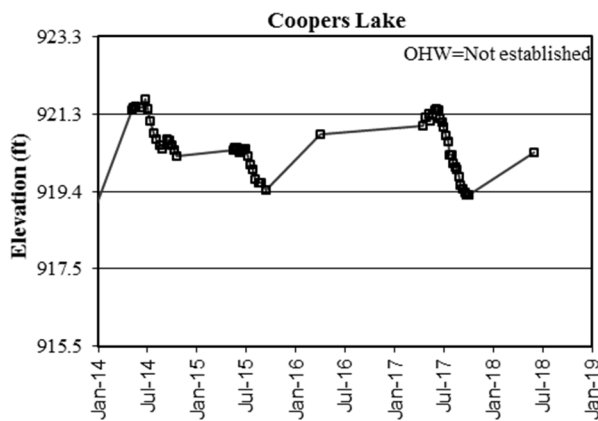
**\*Coopers Lake Levels – last 5 years**

\*Only one reading was obtained for Coopers Lake in 2018. A new volunteer will be pursued for 2019.

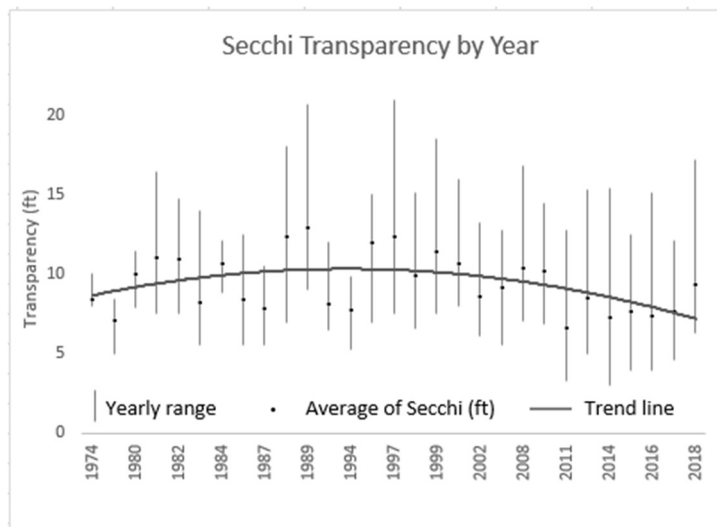
**Lake George Secchi transparency trend:** Includes years with partial datasets not covering all open water months. Those years are excluded from ACD's statistical analysis and graphs later in the document.

Twenty-nine years of water quality data have been collected by the Metropolitan Council (between 1980 and 2009) and the Anoka Conservation District (1997, 1999, 2000, 2002, 2005, 2008, 2011, 2013- 2018). During this period there is a statistically significant trend of declining Secchi transparency (one-way ANOVA  $F_{1,19}=14.37$ ,  $p<0.05$ ). The Rum River Watershed Restoration and Protection Strategy (WRAPS) report also found strong evidence of declining water clarity using a Kendall-Mann statistical analysis. However, an Anoka Conservation District broader analysis of overall water quality that simultaneously considers TP, Cl-a and Secchi transparency did not find a statistically significant trend looking at all years of data (repeated measures MANOVA with response variables TP, Cl-a, and Secchi depth,  $F_{2,18}=1.62$ ,  $p=0.22$ ). Last year, when only the last 10 sampling years' worth of data since 2000 were analyzed a statistically significant increase in TP was apparent (one-way ANOVA  $F_{1,19}=2.23$ ,  $p<0.05$ ) as well as a trend (though not significant) towards increased Cl-a. However, when the last 10 years of sampling were analyzed again this year there were no statistically significant trends. Much of the decline in transparency has occurred since the year 2000 or slightly before. In short, from 2000 to 2017 a trend of poorer (lower) transparency was occurring and a less dramatic trend of poorer (higher) total phosphorus was occurring. Chlorophyll-a (algae) levels show no statistically significant trend of change. This year these trends have disappeared due to the best Secchi and total phosphorus readings in ten years but they could easily reappear in future years and we should not be complacent in monitoring of or managing for water quality in Lake George.

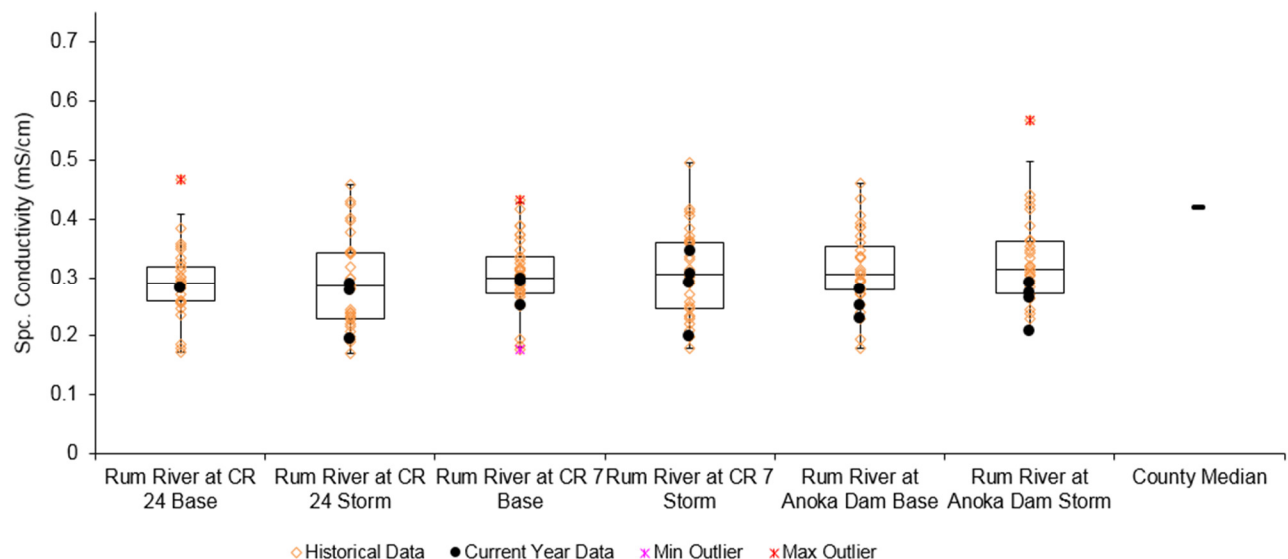
**Specific Conductivity during Baseflow and Storm Conditions.** Orange diamonds are historical data from previous years and black circles are 2018 readings. Box plots show the median (middle line), 25<sup>th</sup> and 75<sup>th</sup> percentile (ends of box), and 10<sup>th</sup> and 90<sup>th</sup> percentiles (floating outer lines).

Specific conductivity is acceptably low in the Rum River, in the past it has shown a consistent pattern of increasing downstream (see figure below) and is usually higher during baseflow conditions. Average specific conductivity from upstream to downstream in 2018 (all conditions) did not meet these expectations with readings of 0.266 mS/cm, 0.282 and 0.269 mS/cm, respectively. All three sites are lower than the historical median for 34 Anoka County streams of 0.420 mS/cm and. The 2018 maximum observed specific conductivity in the Rum River was 0.347 mS/cm at County Road 7 during storm conditions. During storm flows there is a statistically significant trend of increasing specific conductivity from upstream to downstream when averaged over the last 5 years.

Specific conductivity is lower on average during storm events (especially at the upstream sites), suggesting that stormwater runoff contains fewer dissolved pollutants than the surficial water table that feeds the river during baseflow. High baseflow specific conductivity has been observed in most other nearby streams as well. This occurrence has been studied extensively, and the largest cause has often been found to be road deicing salts that have infiltrated into the shallow aquifer. Water softening salts and geologic materials also contribute, but to a lesser degree.

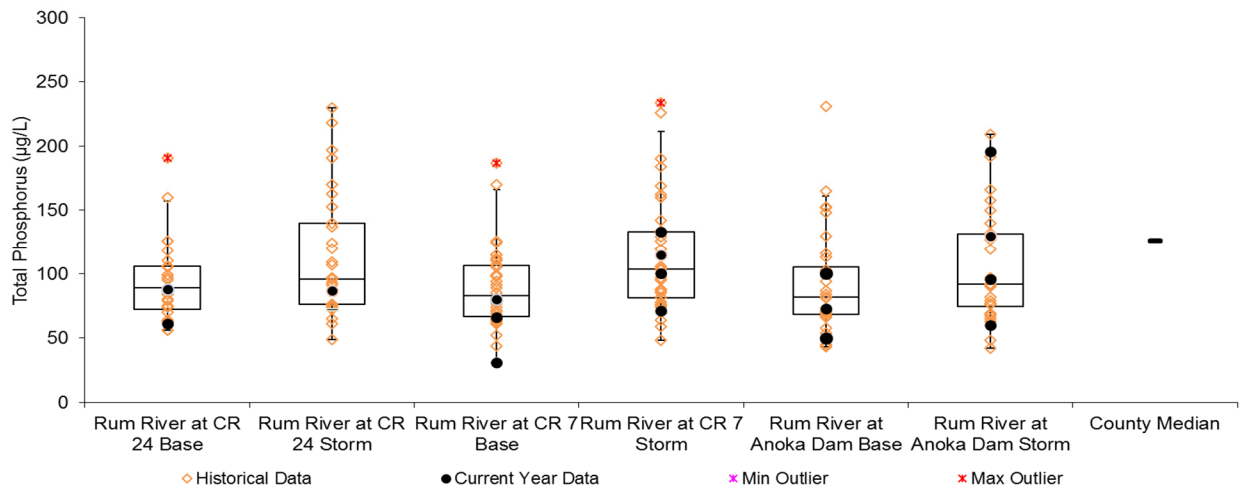
**Total Phosphorus during Baseflow and Storm Conditions.** Orange diamonds are historical data from previous years and black circles are 2018 readings. Box plots show the median (middle line), 25th and 75th percentile (ends of box), and 10th and 90th percentile (floating outer lines).

Phosphorus is one of the most common pollutants in this region, and can be associated with urban runoff, agricultural runoff, wastewater, and many other sources. It causes excessive algal growth and a number of other associated problems for aquatic life and recreation. Rum River total phosphorus is near State impairment thresholds.

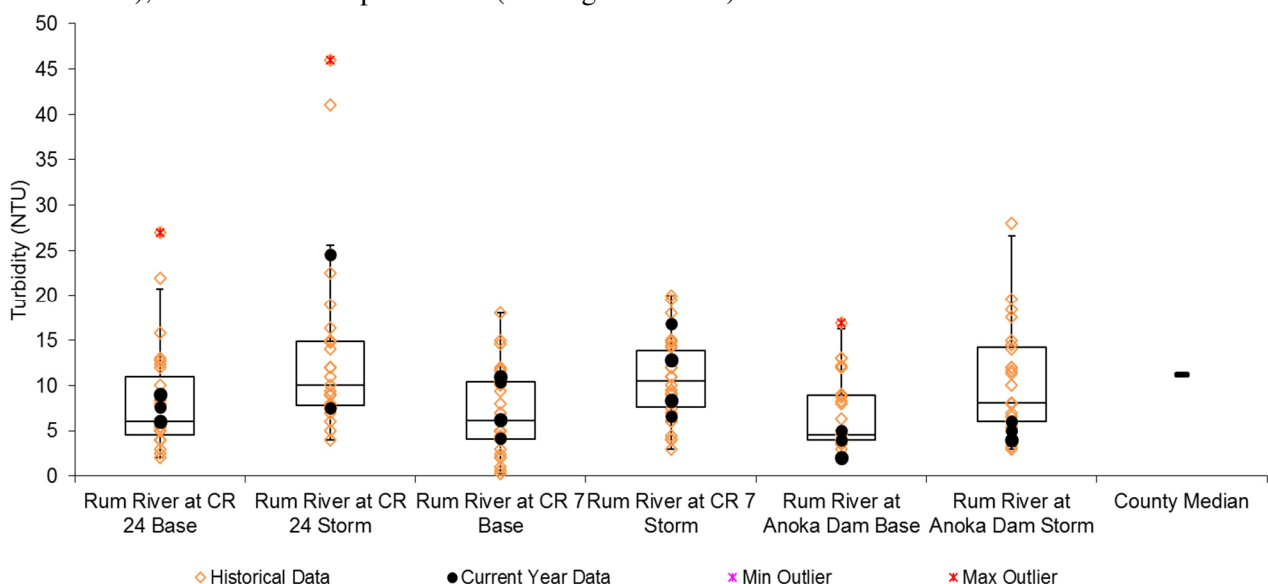
**Turbidity during Baseflow and Storm Conditions.** Orange diamonds are historical data from previous years and black circles are 2018 readings. Box plots show the median (middle line), 25<sup>th</sup> and 75<sup>th</sup> percentile (ends of box), and 10<sup>th</sup> and 90<sup>th</sup> percentiles (floating outer lines).

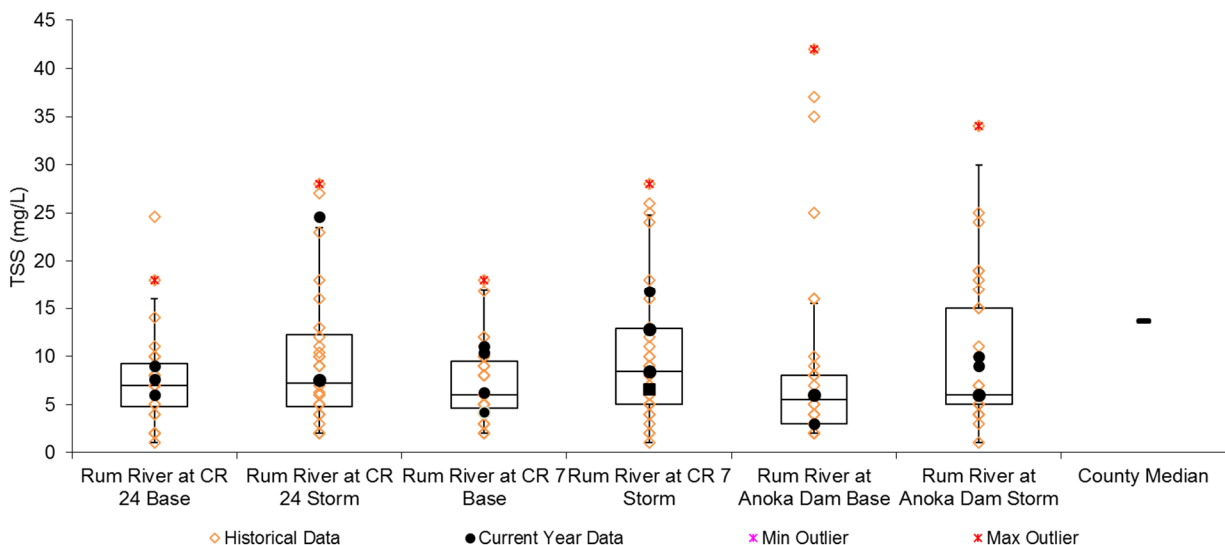
**Total Suspended Solids during Baseflow and Storm Conditions.** Orange diamonds are historical data from previous years and black circles are 2018 readings. Box plots show the median (middle line), 25<sup>th</sup> and 75<sup>th</sup> percentile (ends of box), and 10<sup>th</sup> and 90<sup>th</sup> percentiles (floating outer lines).

Average TSS results (all conditions) in 2018 for sites moving upstream to downstream were 10.94, 10.1, and 5.54 mg/L. These are all lower than the Anoka County stream median for TSS of 13.66 mg/L. It is also lower than State water quality standards. The State threshold for TSS impairment in the Rum River is 10% of samples April 1-September 30 exceeding 30 mg/L TSS. The highest concentration recorded in 2018 was 24 mg/L. ACD has not collected a sample over 30 mg/L TSS since May of 2010.

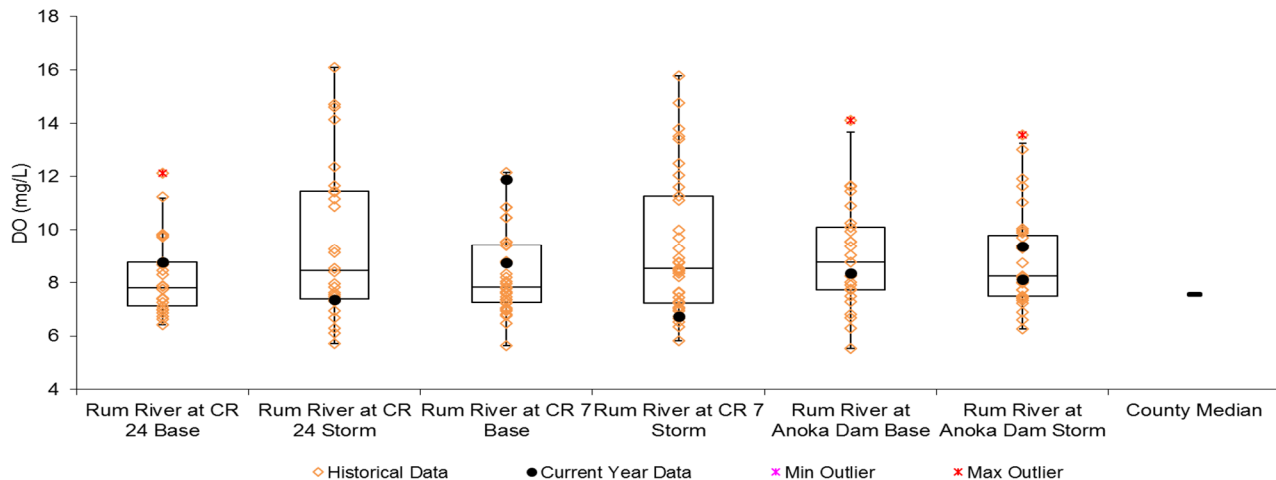
**Dissolved Oxygen during Baseflow and Storm Conditions.** Orange diamonds are historical data from previous years and black circles are 2018 readings. Box plots show the median (middle line), 25<sup>th</sup> and 75<sup>th</sup> percentile (ends of box), and 10<sup>th</sup> and 90<sup>th</sup> percentiles (floating outer lines).

Dissolved oxygen is necessary for aquatic life, including fish. Organic pollution causes oxygen to be consumed during decomposition. If oxygen levels fall below the state water quality standard of 5 mg/L, aquatic life begins to suffer. A stream is considered impaired if 10% of observations are below this level in the last 10 years. Dissolved oxygen levels are typically lowest in the early morning because of decomposition consuming oxygen at night without offsetting oxygen production by photosynthesis. In 2018, dissolved oxygen in the Rum River was always above 5 mg/L at all monitoring sites.

The lowest dissolved oxygen observed in the Rum River in 2018 was 5.64 mg/L. This is only the fifth time that a dissolved oxygen reading below 6 has occurred in the Rum River throughout the monitoring record, with the 3 most recent previous readings occurring during a single storm in 2011 when dissolved oxygen dipped below six at all three sites.

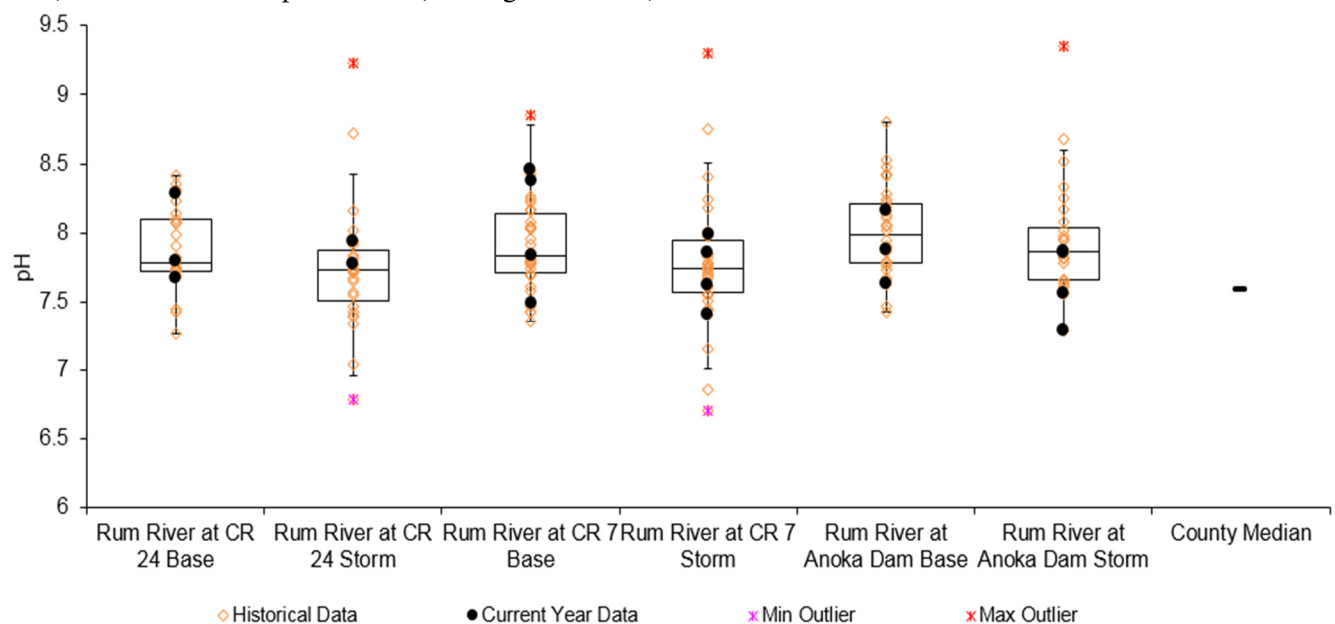
**pH during Baseflow and Storm Conditions.** Orange diamonds are historical data from previous years and black circles are 2018 readings. Box plots show the median (middle line), 25<sup>th</sup> and 75<sup>th</sup> percentile (ends of box), and 10<sup>th</sup> and 90<sup>th</sup> percentiles (floating outer lines).

pH refers to the acidity of the water. The Minnesota Pollution Control Agency's water quality standard is for pH to remain between 6.5 and 8.5. The Rum River is generally within this range, but has exceeded 8.5 on rare occasions in the past. In recent years (2015, 2017) however, exceedances of 8.5 have been commonplace at all sites. In 2017, pH levels over 9 were recorded at all three sites after a storm event on 5/18/2017. Exceedances were recorded in 2015 after a spring storm in March at the lower two sampling sites as well as at the Anoka Dam during baseflow conditions in July. This year saw a positive change with no events exceeding 8.5.

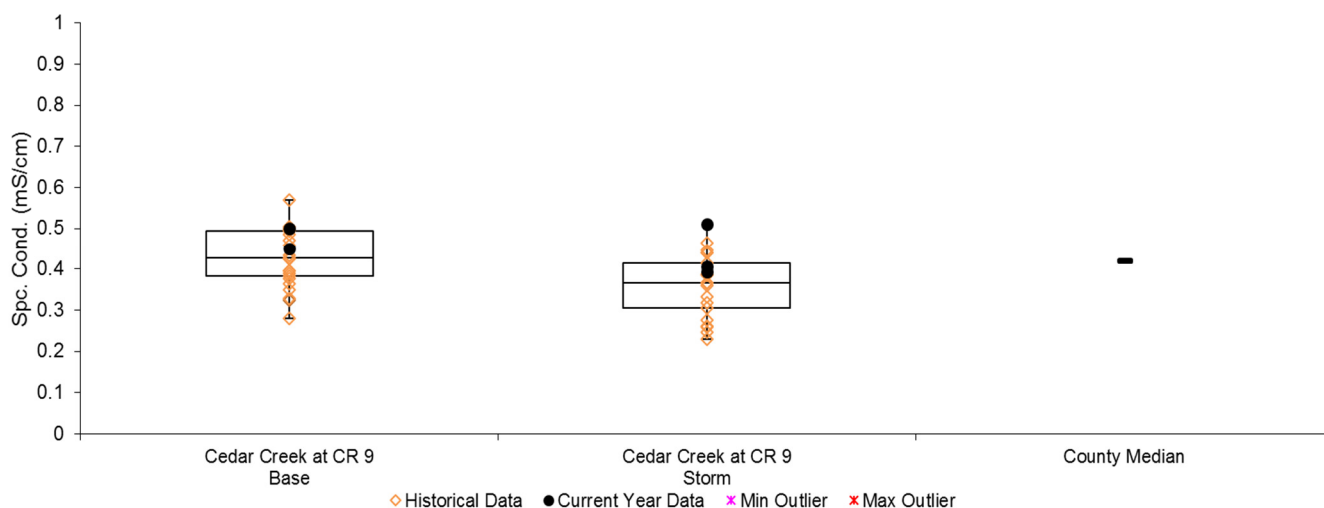
**Specific Conductivity during Baseflow and Storm Conditions.** Orange diamonds are historical data from previous years and black circles are 2018 readings. Box plots show the median (middle line), 25<sup>th</sup> and 75<sup>th</sup> percentile (ends of box), and 10<sup>th</sup> and 90<sup>th</sup> percentiles (floating outer lines).

Specific conductivity is right on par in Cedar Creek at CR 9 compared to other Anoka County streams. Median specific conductivity (all years) is 0.426 mS/cm during baseflow and 0.363 mS/cm during storm events, respectively. The long-term countywide median specific conductivity for all conditions is 0.420 mS/cm. However, this includes many heavily urbanized streams, which Cedar Creek is not.

Baseflow specific conductivity appears to be higher over the last few sampling years (since 2014). The median baseflow specific conductivity since 2014 is 0.485 mS/cm, above the long-term median suggesting increasing levels. However, the median storm flow specific conductivity since 2014, 0.319 mS/cm, is lower than the long-term average.

This increase in baseflow specific conductivity levels reveals some information about sources of loading into the stream. Higher levels at baseflow conditions indicate that the surficial groundwater of the watershed is being loaded with salts and other chemicals that increase specific conductivity. Some common sources of this type of pollution are road salts, water softeners, septic leaks, and agricultural chemicals. These constituents that raise specific conductivity appear to be entering the stream in higher concentrations from the local surficial groundwater. Storm runoff then dilutes specific conductivity levels during rain events.

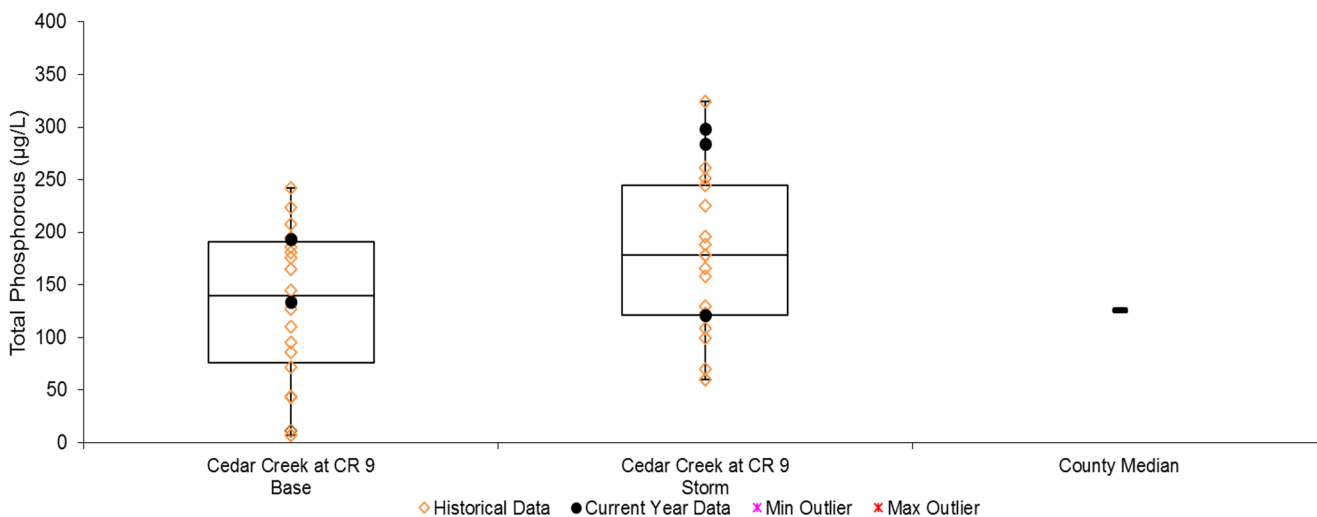
**Total Phosphorus during Baseflow and Storm Conditions.** Orange diamonds are historical data from previous years and black circles are 2018 readings. Box plots show the median (middle line), 25<sup>th</sup> and 75<sup>th</sup> percentile (ends of box), and 10<sup>th</sup> and 90<sup>th</sup> percentiles (floating outer lines).

Total phosphorus in Cedar Creek remained high in 2018 averaging 227 µg/L during all conditions. This nutrient is one of the most common pollutants in our region, and can be associated with urban runoff, agricultural runoff, wastewater, and many other sources.

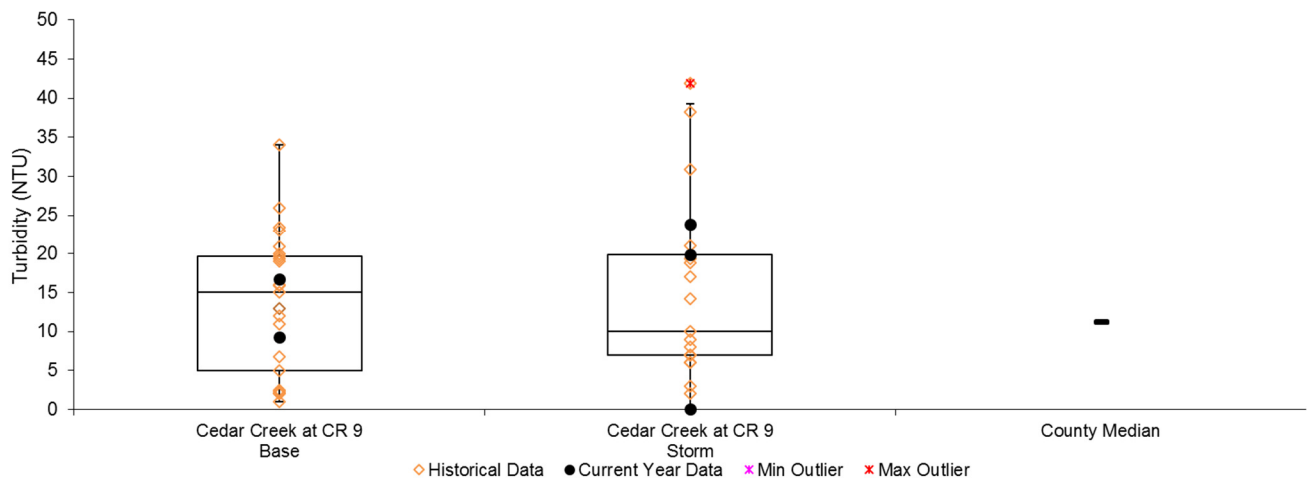
**Turbidity during Baseflow and Storm Conditions.** Orange diamonds are historical data from previous years and black circles are 2018 readings. Box plots show the median (middle line), 25<sup>th</sup> and 75<sup>th</sup> percentile (ends of box), and 10<sup>th</sup> and 90<sup>th</sup> percentiles (floating outer lines).

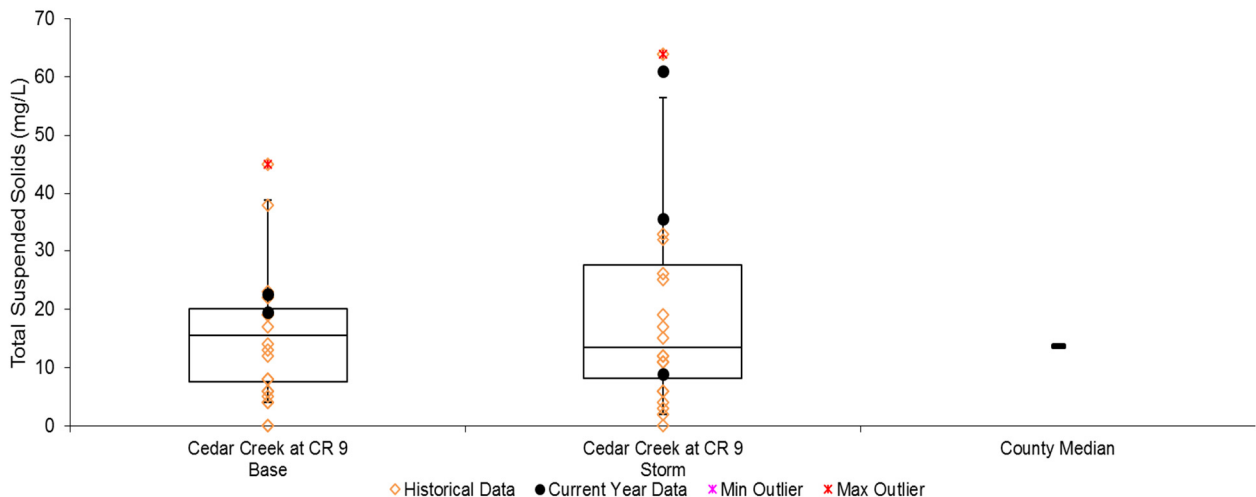
**Total Suspended Solids during Baseflow and Storm Conditions.** Orange diamonds are historical data from previous years and black circles are 2018 readings. Box plots show the median (middle line), 25<sup>th</sup> and 75<sup>th</sup> percentile (ends of box), and 10<sup>th</sup> and 90<sup>th</sup> percentiles (floating outer lines).

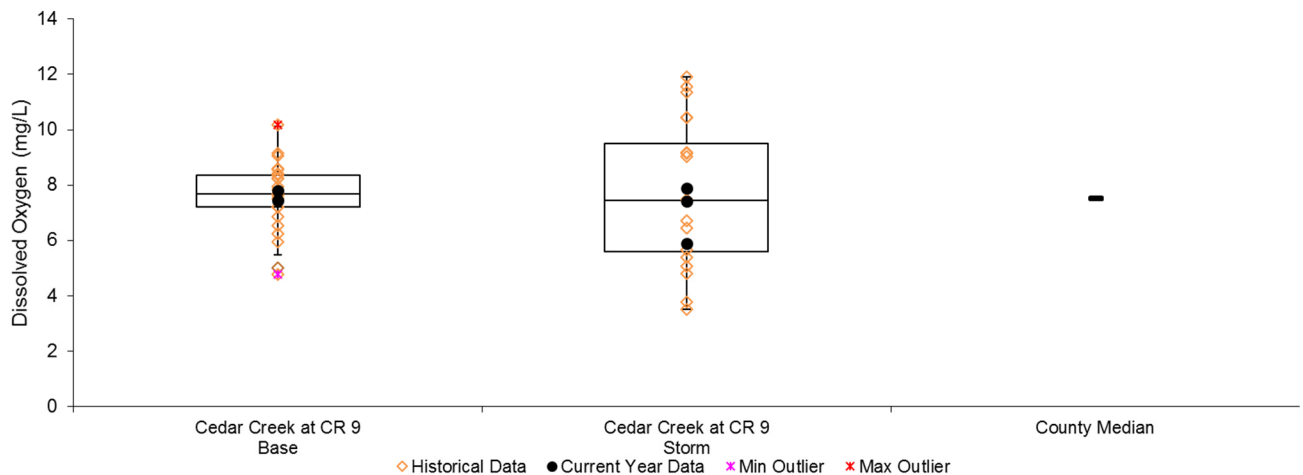
**Dissolved Oxygen during Baseflow and Storm Conditions.** Orange diamonds are historical data from previous years and black circles are 2018 readings. Box plots show the median (middle line), 25<sup>th</sup> and 75<sup>th</sup> percentile (ends of box), and 10<sup>th</sup> and 90<sup>th</sup> percentiles (floating outer lines).

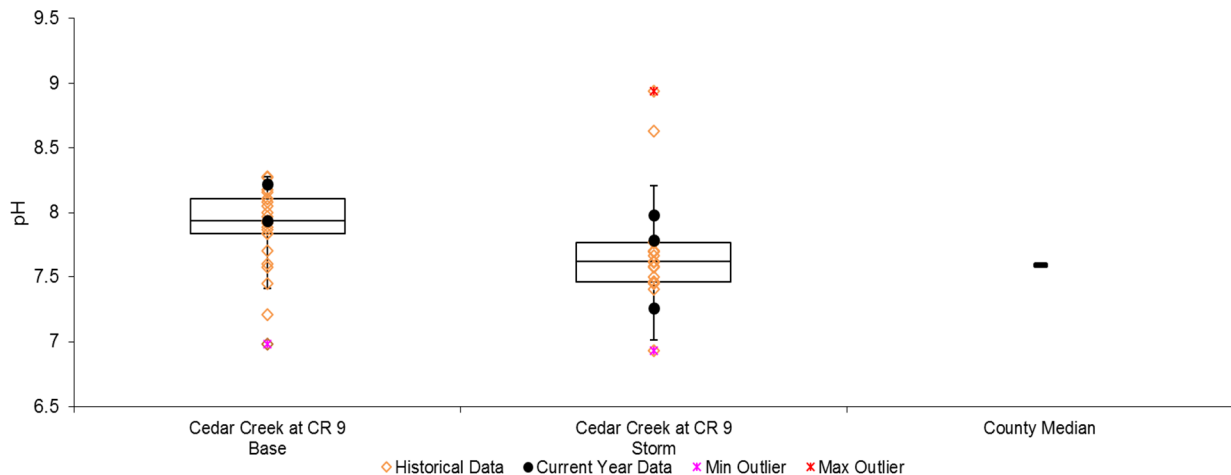
**pH during Baseflow and Storm Conditions.** Orange diamonds are historical data from previous years and black circles are 2018 readings. Box plots show the median (middle line), 25<sup>th</sup> and 75<sup>th</sup> percentile (ends of box), and 10<sup>th</sup> and 90<sup>th</sup> percentiles (floating outer lines).

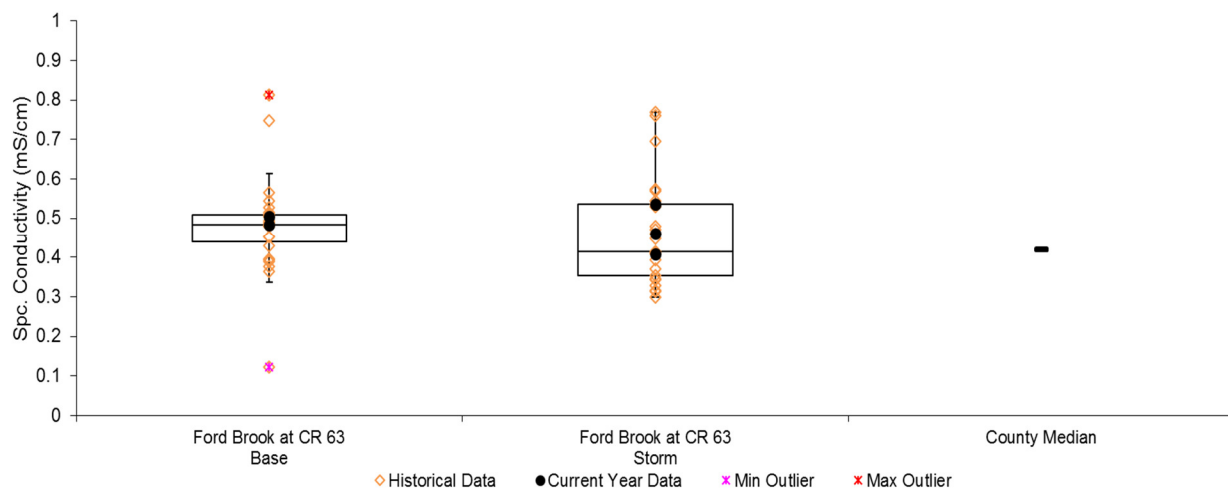
**Specific Conductivity at Ford Brook.** Orange diamonds are historical data from previous years and black circles are 2018 readings. Box plots show the median (middle line), 25<sup>th</sup> and 75<sup>th</sup> percentile (ends of box), and 10<sup>th</sup> and 90<sup>th</sup> percentiles (floating outer lines).

A likely cause of the increase in specific conductivity in streams at baseflow is chlorides from road salting. Water softener discharge or dissolved pollutants can also contribute. These salts both runoff into the water and infiltrate into the shallow groundwater that feeds the stream during baseflow. Periodic chloride sampling to assess the contribution of salts to the dissolved pollutant load is recommended.

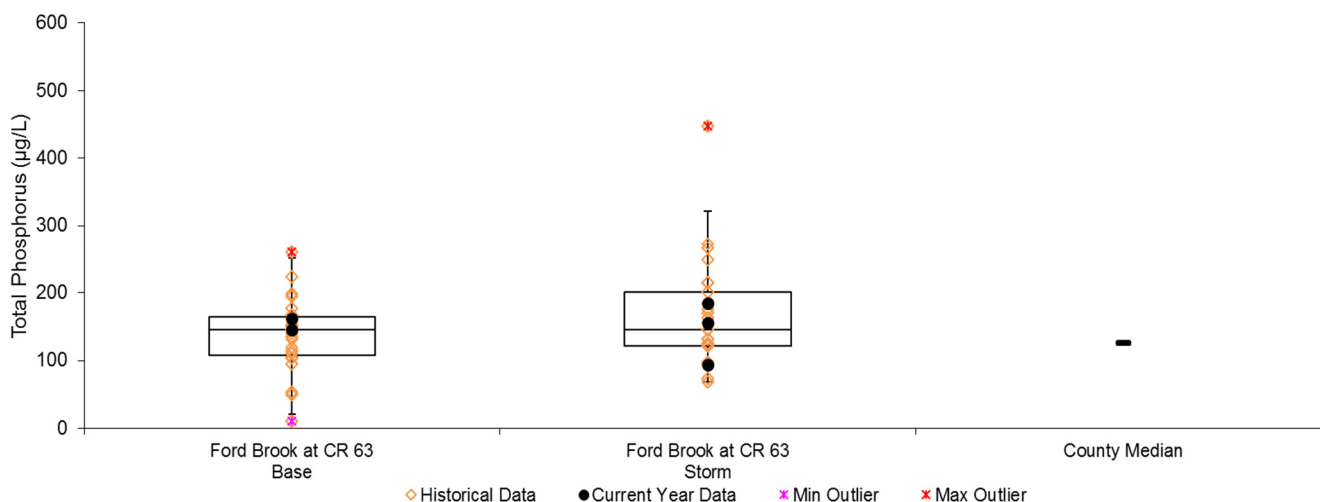
**Total Phosphorus at Ford Brook.** Orange diamonds are historical data from previous years and black circles are 2018 readings. Box plots show the median (middle line), 25<sup>th</sup> and 75<sup>th</sup> percentile (ends of box), and 10<sup>th</sup> and 90<sup>th</sup> percentiles (floating outer lines).

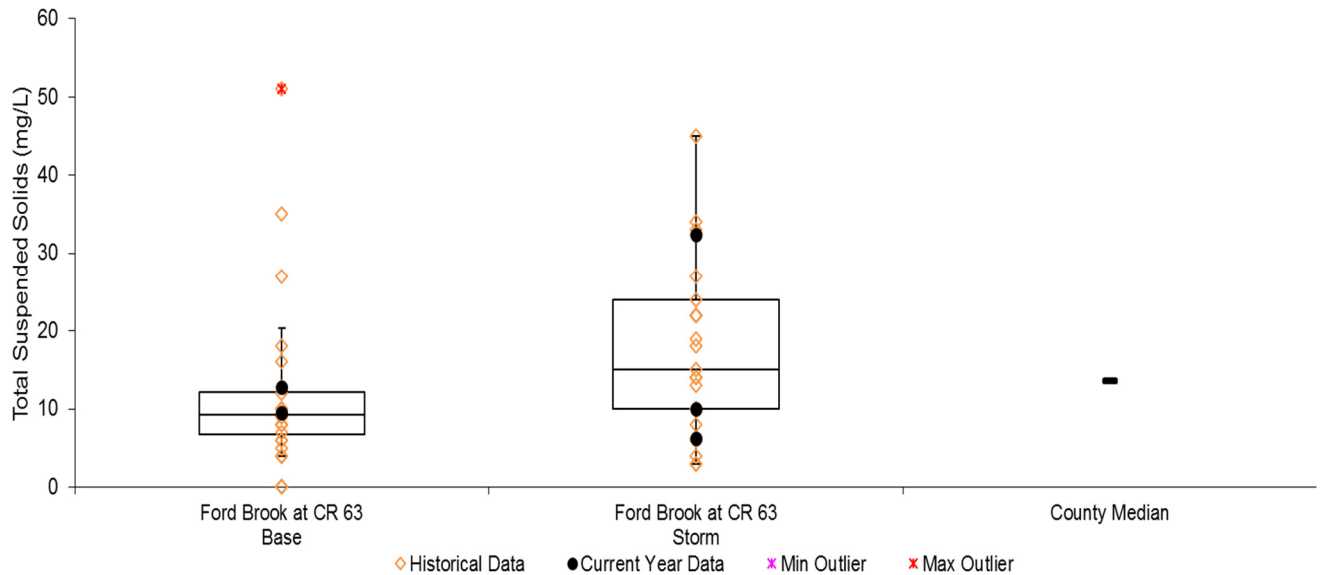
**Total Suspended Solids at Ford Brook.** Orange diamonds are historical data from previous years and black circles are 2018 readings. Box plots show the median (middle line), 25<sup>th</sup> and 75<sup>th</sup> percentile (ends of box), and 10<sup>th</sup> and 90<sup>th</sup> percentiles (floating outer lines).

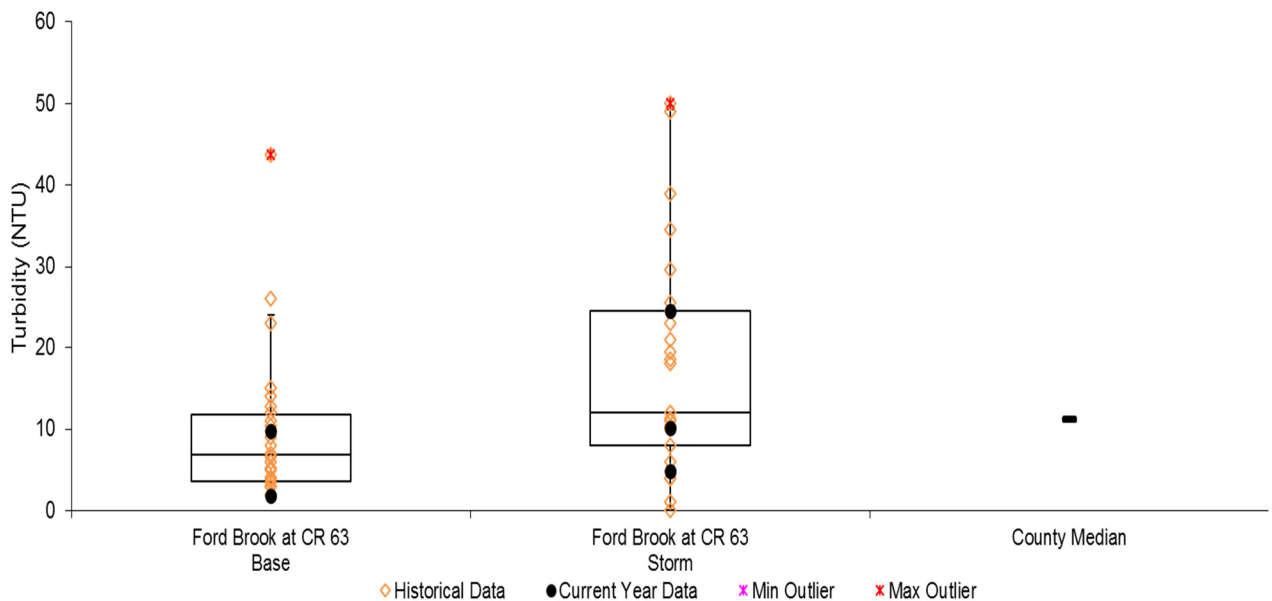
**Turbidity at Ford Brook.** Orange diamonds are historical data from previous years and black circles are 2018 readings. Box plots show the median (middle line), 25<sup>th</sup> and 75<sup>th</sup> percentile (ends of box), and 10<sup>th</sup> and 90<sup>th</sup> percentiles (floating outer lines).

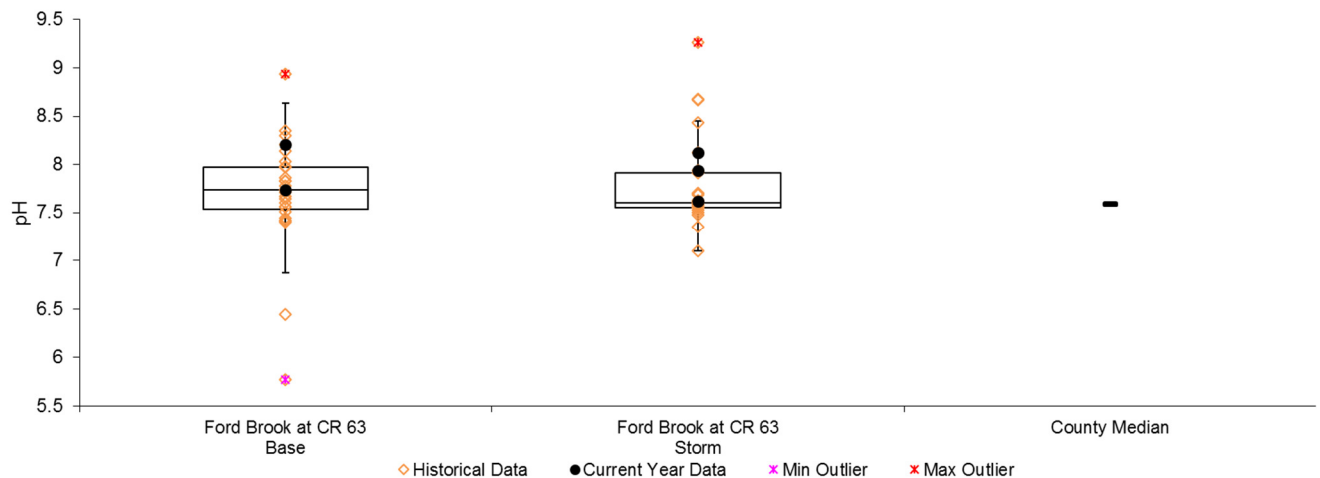
**pH at Ford Brook.** Orange diamonds are historical data from previous years and black circles are 2018 readings. Box plots show the median (middle line), 25<sup>th</sup> and 75<sup>th</sup> percentile (ends of box), and 10<sup>th</sup> and 90<sup>th</sup> percentiles (floating outer lines).

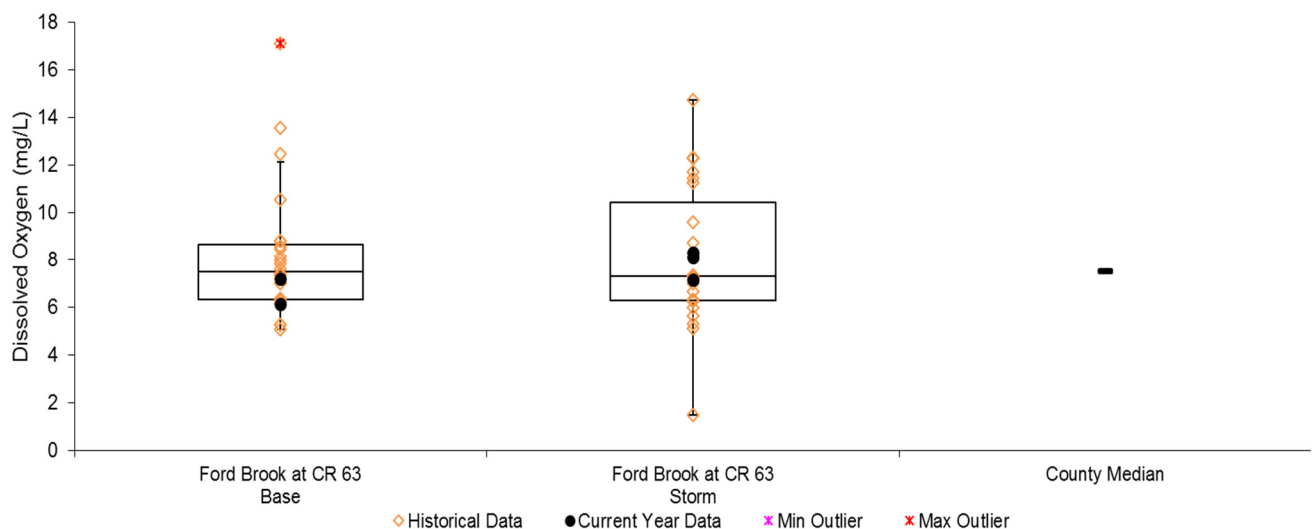
**Dissolved Oxygen at Ford Brook.** Orange diamonds are historical data from previous years and black circles are 2018 readings. Box plots show the median (middle line), 25<sup>th</sup> and 75<sup>th</sup> percentile (ends of box), and 10<sup>th</sup> and 90<sup>th</sup> percentiles (floating outer lines).

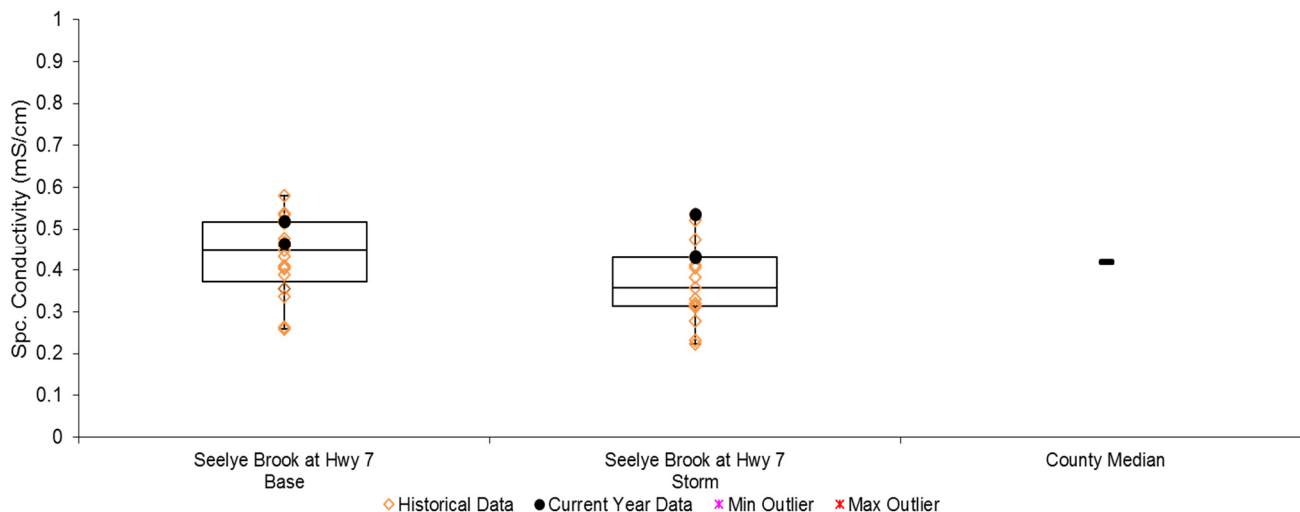
**Specific Conductivity during Baseflow and Storm Conditions.** Orange diamonds are historical data from previous years and black circles are 2018 readings. Box plots show the median (middle line), 25<sup>th</sup> and 75<sup>th</sup> percentile (ends of box), and 10<sup>th</sup> and 90<sup>th</sup> percentiles (floating outer lines).

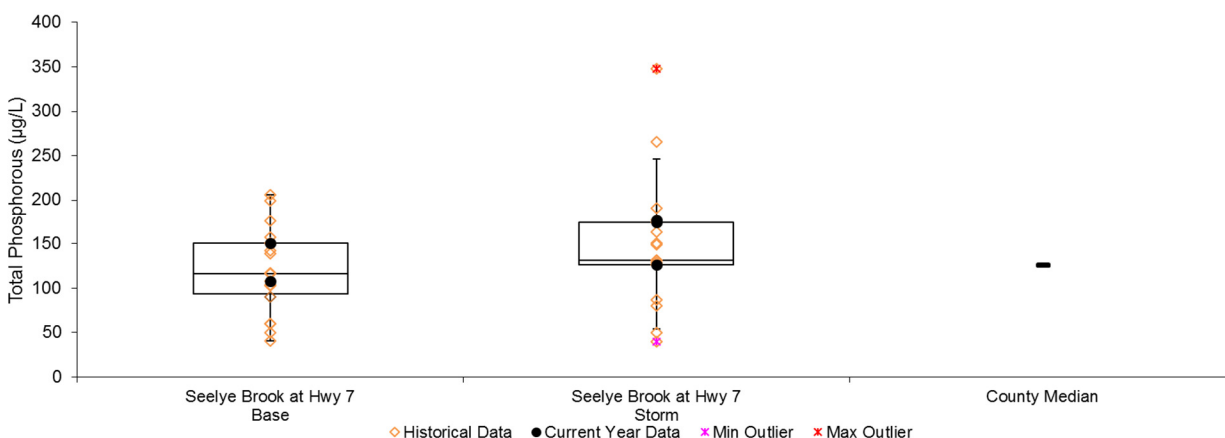
**Total Phosphorus during Baseflow and Storm Conditions.** Orange diamonds are historical data from previous years and black circles are 2018 readings. Box plots show the median (middle line), 25<sup>th</sup> and 75<sup>th</sup> percentile (ends of box), and 10<sup>th</sup> and 90<sup>th</sup> percentiles (floating outer lines).

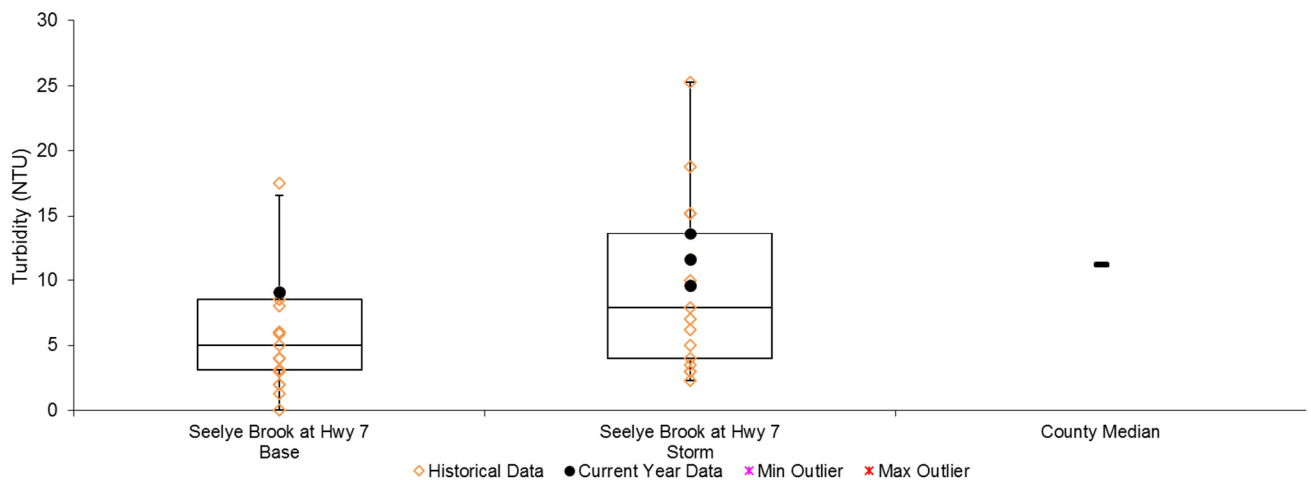
**Turbidity during Baseflow and Storm Conditions.** Orange diamonds are historical data from previous years and black circles are 2018 readings. Box plots show the median (middle line), 25<sup>th</sup> and 75<sup>th</sup> percentile (ends of box), and 10<sup>th</sup> and 90<sup>th</sup> percentiles (floating outer lines).

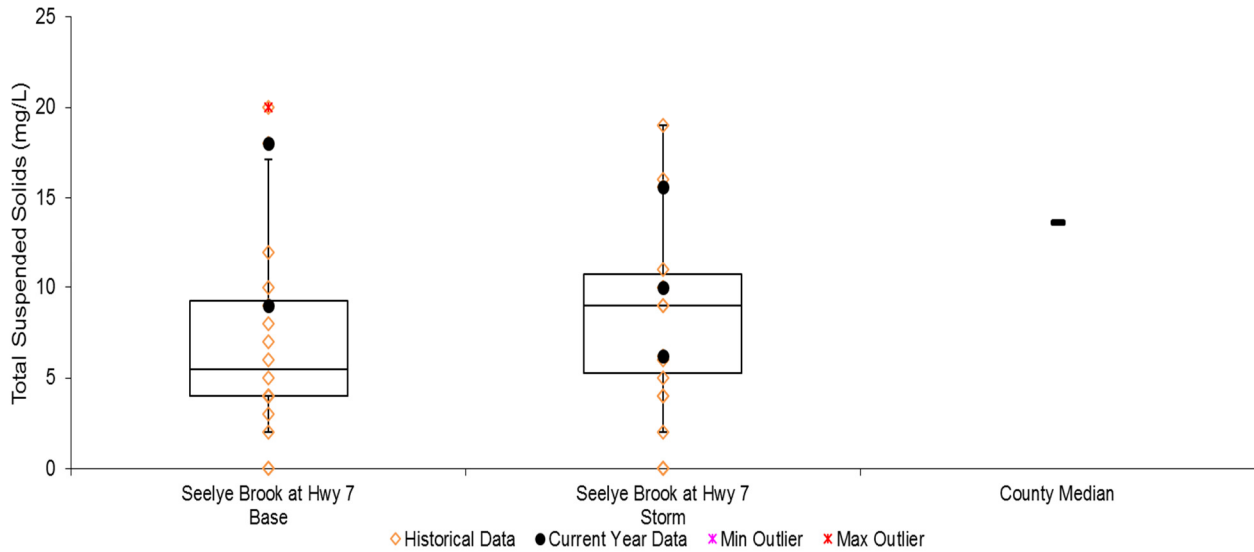
**Total Suspended Solids during Baseflow and Storm Conditions.** Orange diamonds are historical data from previous years and black circles are 2018 readings. Box plots show the median (middle line), 25<sup>th</sup> and 75<sup>th</sup> percentile (ends of box), and 10<sup>th</sup> and 90<sup>th</sup> percentiles (floating outer lines).

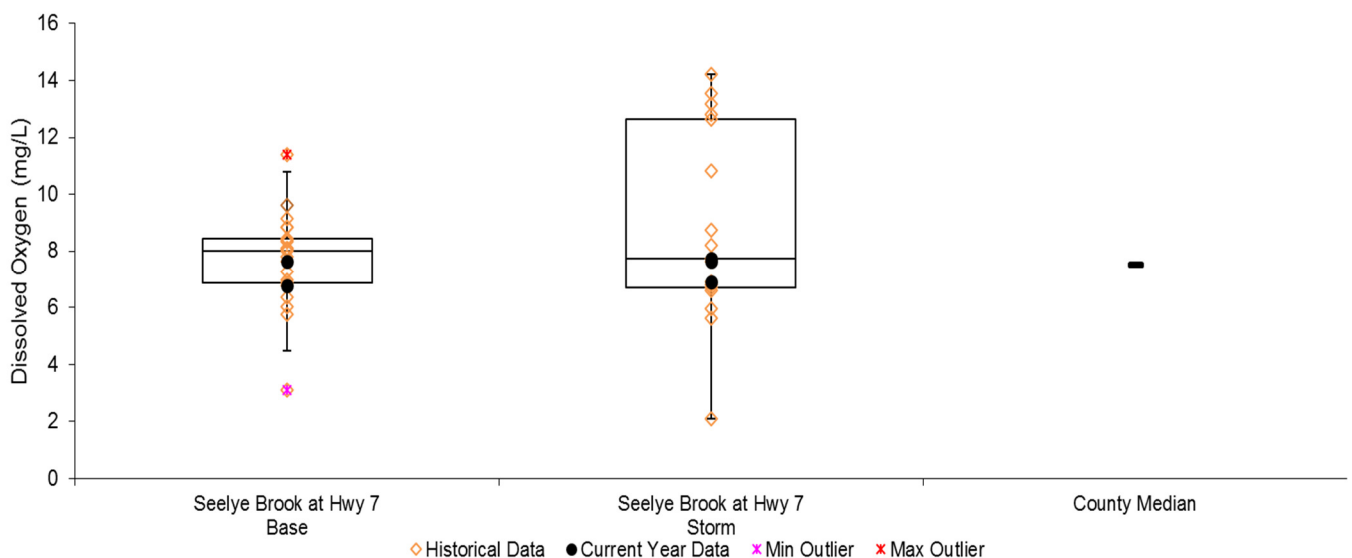
**Dissolved Oxygen during Baseflow and Storm Conditions.** Orange diamonds are historical data from previous years and black circles are 2018 readings. Box plots show the median (middle line), 25<sup>th</sup> and 75<sup>th</sup> percentile (ends of box), and 10<sup>th</sup> and 90<sup>th</sup> percentiles (floating outer lines).
