# Excerpt from the 2019 Water Almanac *Chapter 3: Upper Rum River Watershed*

Prepared by the Anoka Conservation District

## Chapter: 3 Upper Rum River Watershed

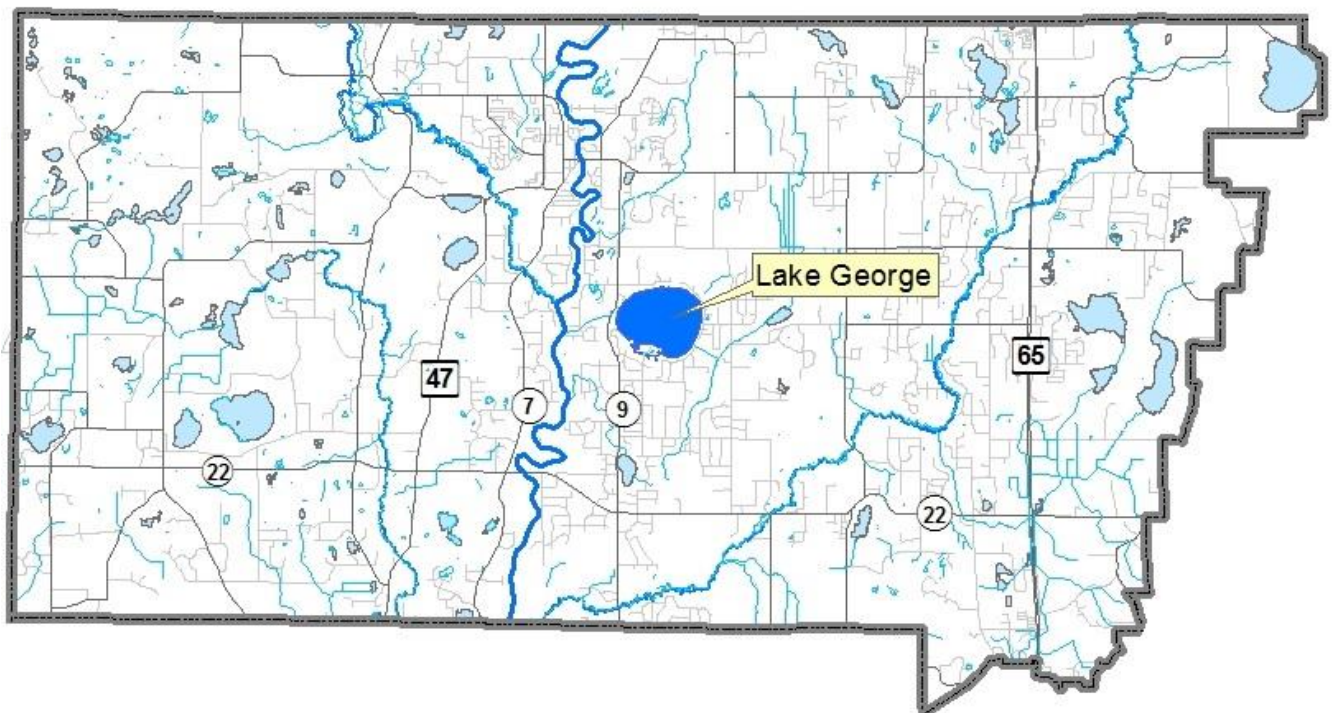
### Upper Rum River Watershed Lake Water Quality Monitoring Sites

**Results:** Detailed data for Lake George is provided on the following pages, including summaries of historical conditions and trend analysis. Previous years' data are available at the MPCA's electronic data access website. Refer to Chapter 1 for additional information on interpreting the data and on lake dynamics.

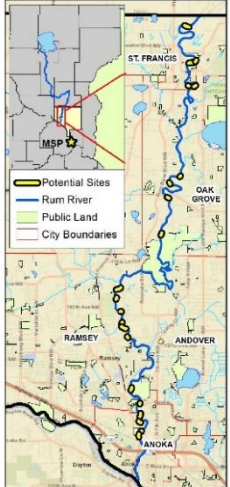
Application illustration for the Lessard-Sams Outdoor Heritage Council to do Rum River stabilization projects utilizing bioengineering approaches. The LSOHC recommended funding these projects at \$952,000 over the next three years, which will be matched with \$236,000 in local funds from Anoka County and the Upper and Lower Rum River WMOs.
