# PETRO STREAMBANK RESTORATION EAST BETHEL, MN

## Project Summary

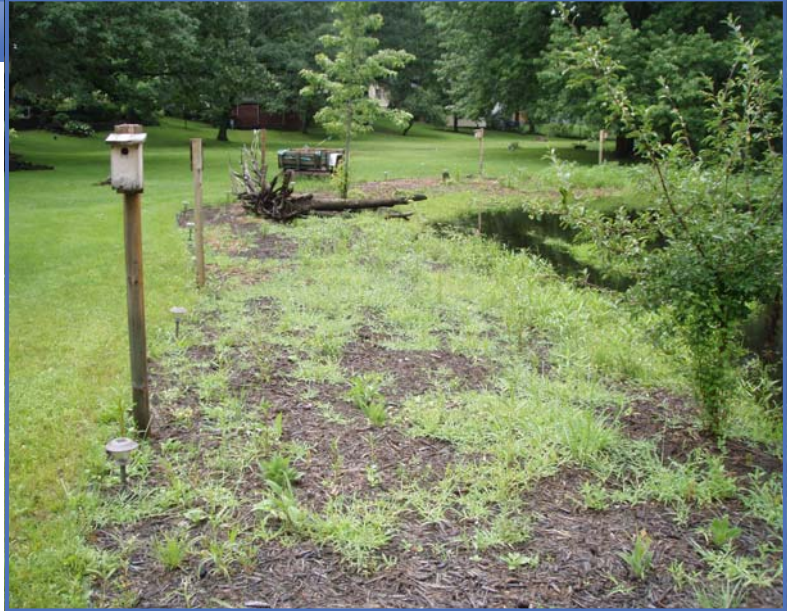
Completed project in the summer of 2011.

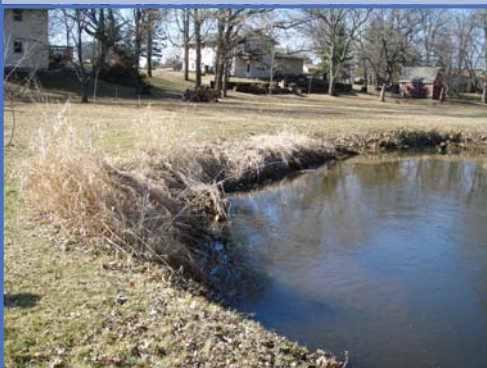
Pre-stabilization conditions consisted of a severely undercut streambank and no buffer, which provided no benefits to water quality or wildlife habitat.

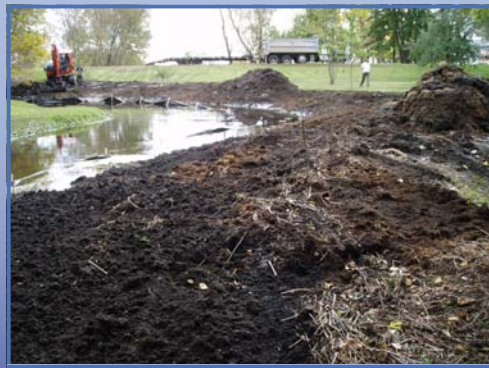
The site was scraped to remove invasive species and graded to achieve the desired slopes prior to planting and biolog installation.

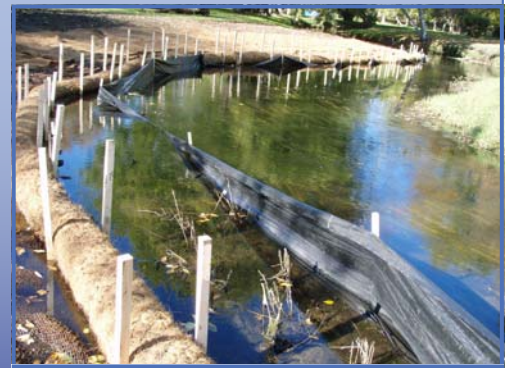
Erosion control fabric with native species plantings and biologs were used to stabilize the shoreline. These bioengineering practices will benefit habitat and water quality.
