LAKE GEORGE SHORE STABILIZATION GRAIZIGER RESIDENCE, OAK GROVE, MN

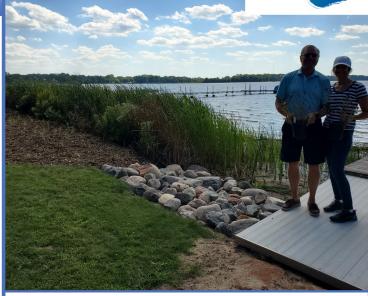
The shore was stabilized using rock rip rap at the dock approach and a native plant buffer elsewhere. Little or no grading was needed, except for rock installation along 25 linear feet. Native plants were installed along the remaining 99 linear ft of the shore to provide 1,386 sq ft of shoreline habitat, conceal present and future ice ridges, and prevent erosion. The design provides some visual screening from foot traffic at an adjacent public easement to the lakeshore. Vegetation is a mix of native shrubs, flowers, and forbs.

Project upon completion. August 2022.
